A Structural Reevaluation of the Collapse of World Trade Center 7

September 2017 Progress Report

Dr. J. Leroy Hulsey, Professor

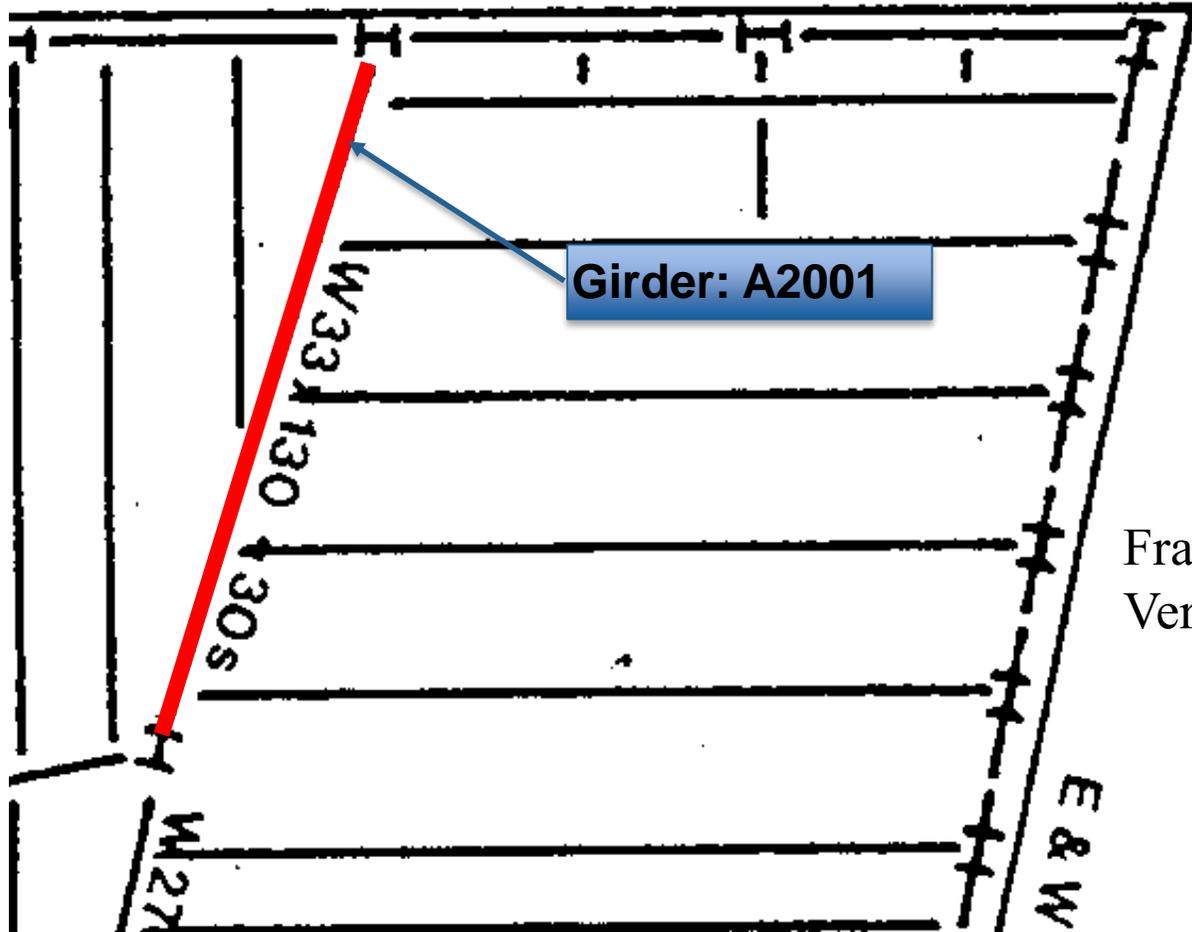
Contrary argument to girder missing shear studs

Plans show: 30 shear studs equally spaced along girder A2001

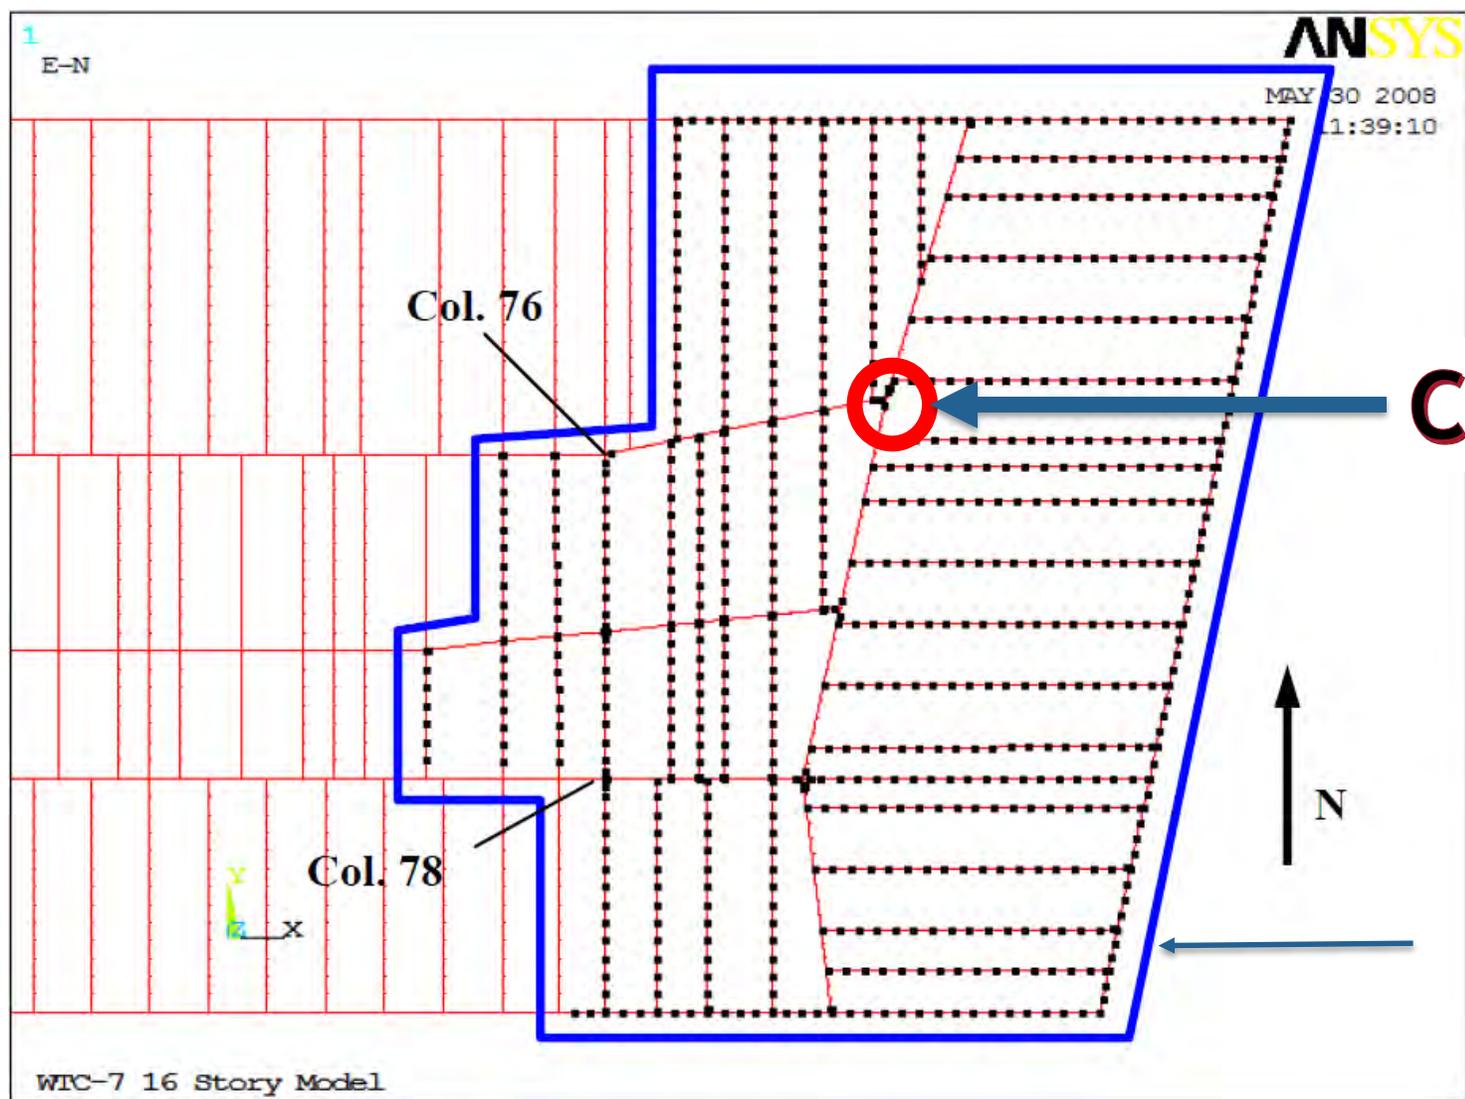
Loss of lateral support for 9 stories (Floors 6 to 13) caused buckling to initiate.

- Buckling initiation points
- No support
- Partial support
- Full Support

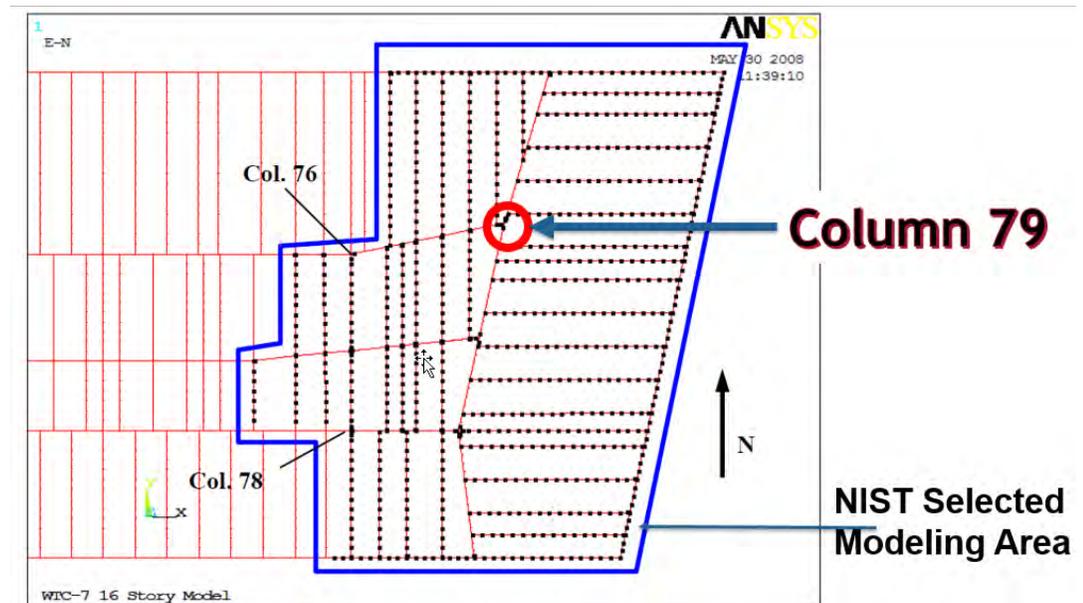
Area of floor where connections were modeled (Floors 8 to 14)
(NIST After, 2004)

1. Outside the selected area, connection failures were not modeled (NIST used fixed or pinned connections).
2. Connections were not modeled for the exterior moment frame.

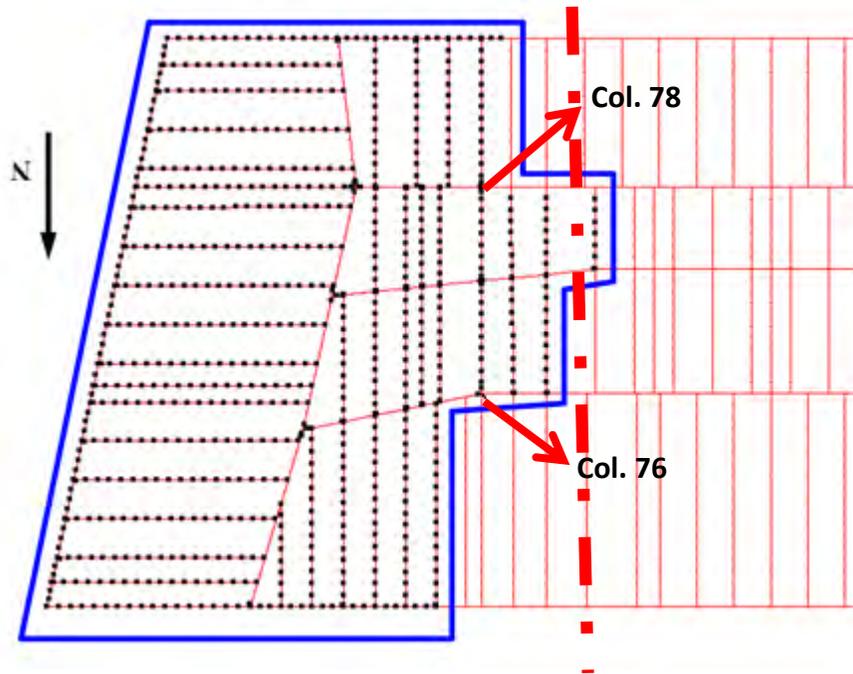
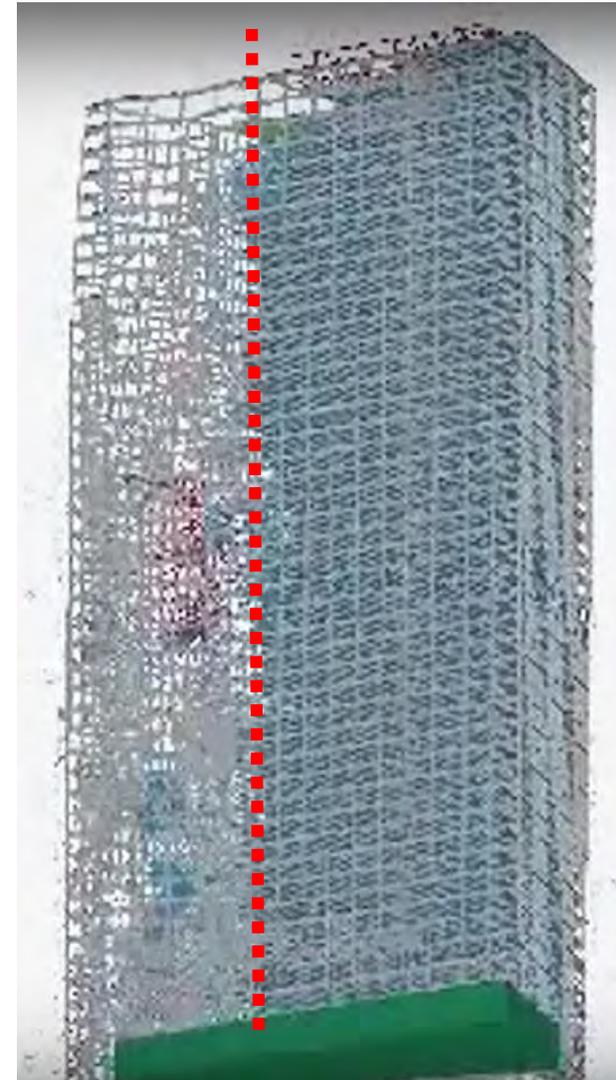
Video vs. NIST WTC7 collapse animation comparison

No exterior column deformation is evident in the actual collapse. Deformation is seen in the NIST model.

Connections were not modeled; outside selected blue space.

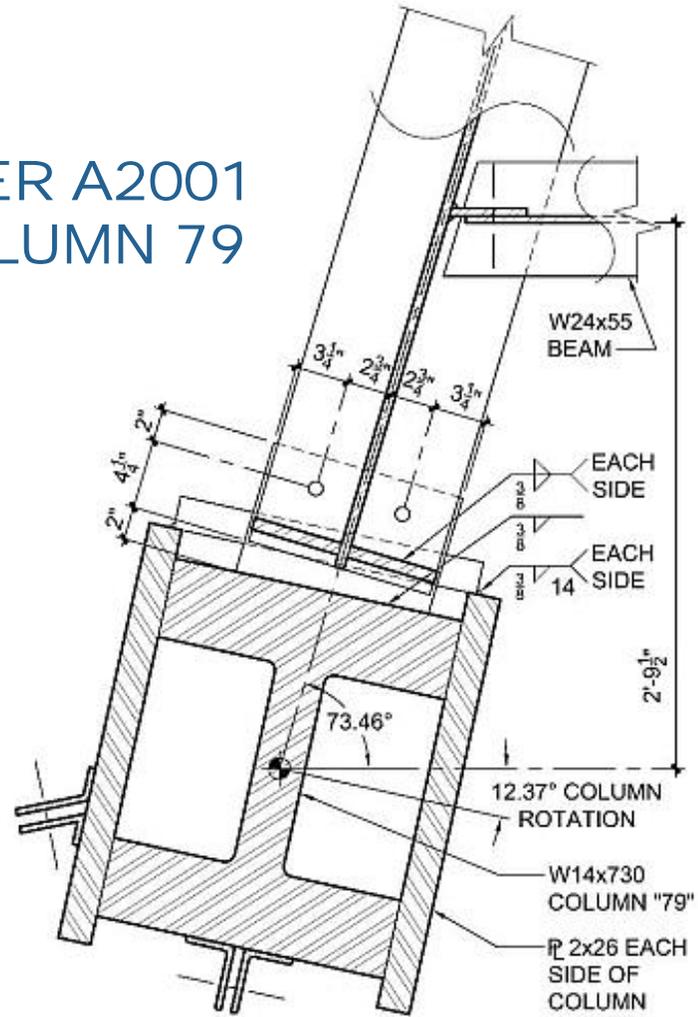
PLAN VIEW OF GIRDER A2001 CONNECTION TO COLUMN 79

Plan View of girder A2001 moving across its bearing seat at column 79 due to thermal expansion of the beams framing into the girder from the east.

Note: This picture illustrates that A2001 is trapped by the column side plate and it is not possible for it to move the girder web beyond the seat as claimed by NIST.

It appears that NIST did not examine the side plate influence on the restriction of movement by the girder.

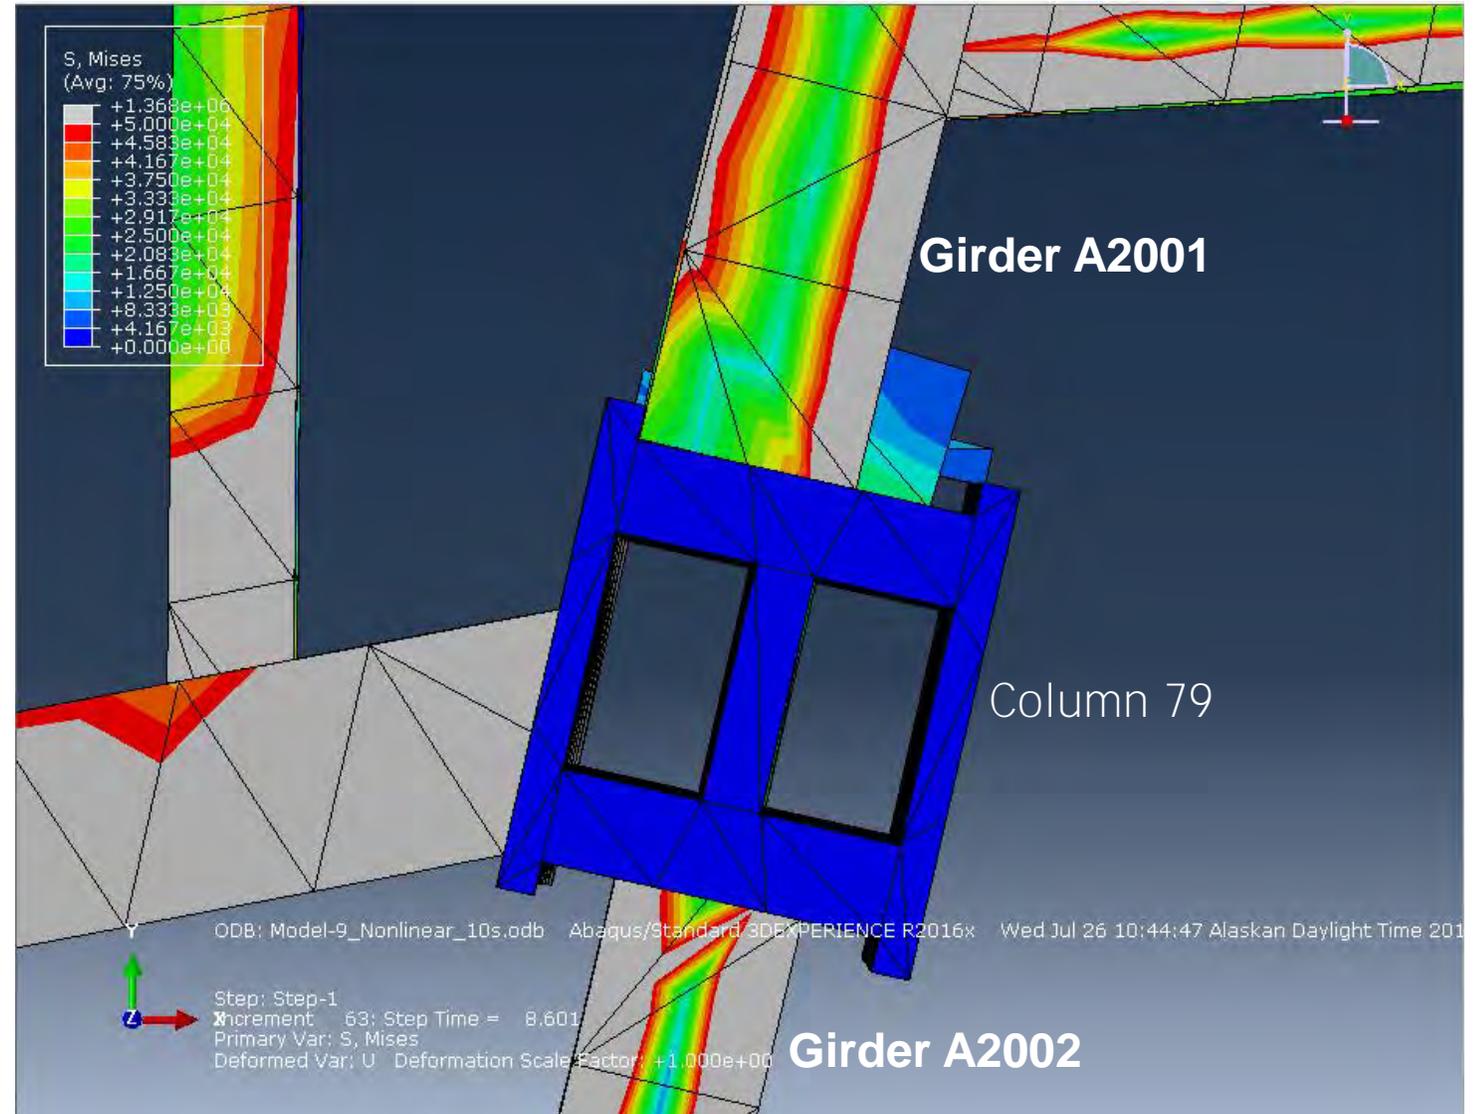
This model shows the influence of the thermal expansion at the north east corner of floor 13.

When girder A2001 is trapped behind the side plate on column 79, beams K3004 and D3004 begin to buckle.

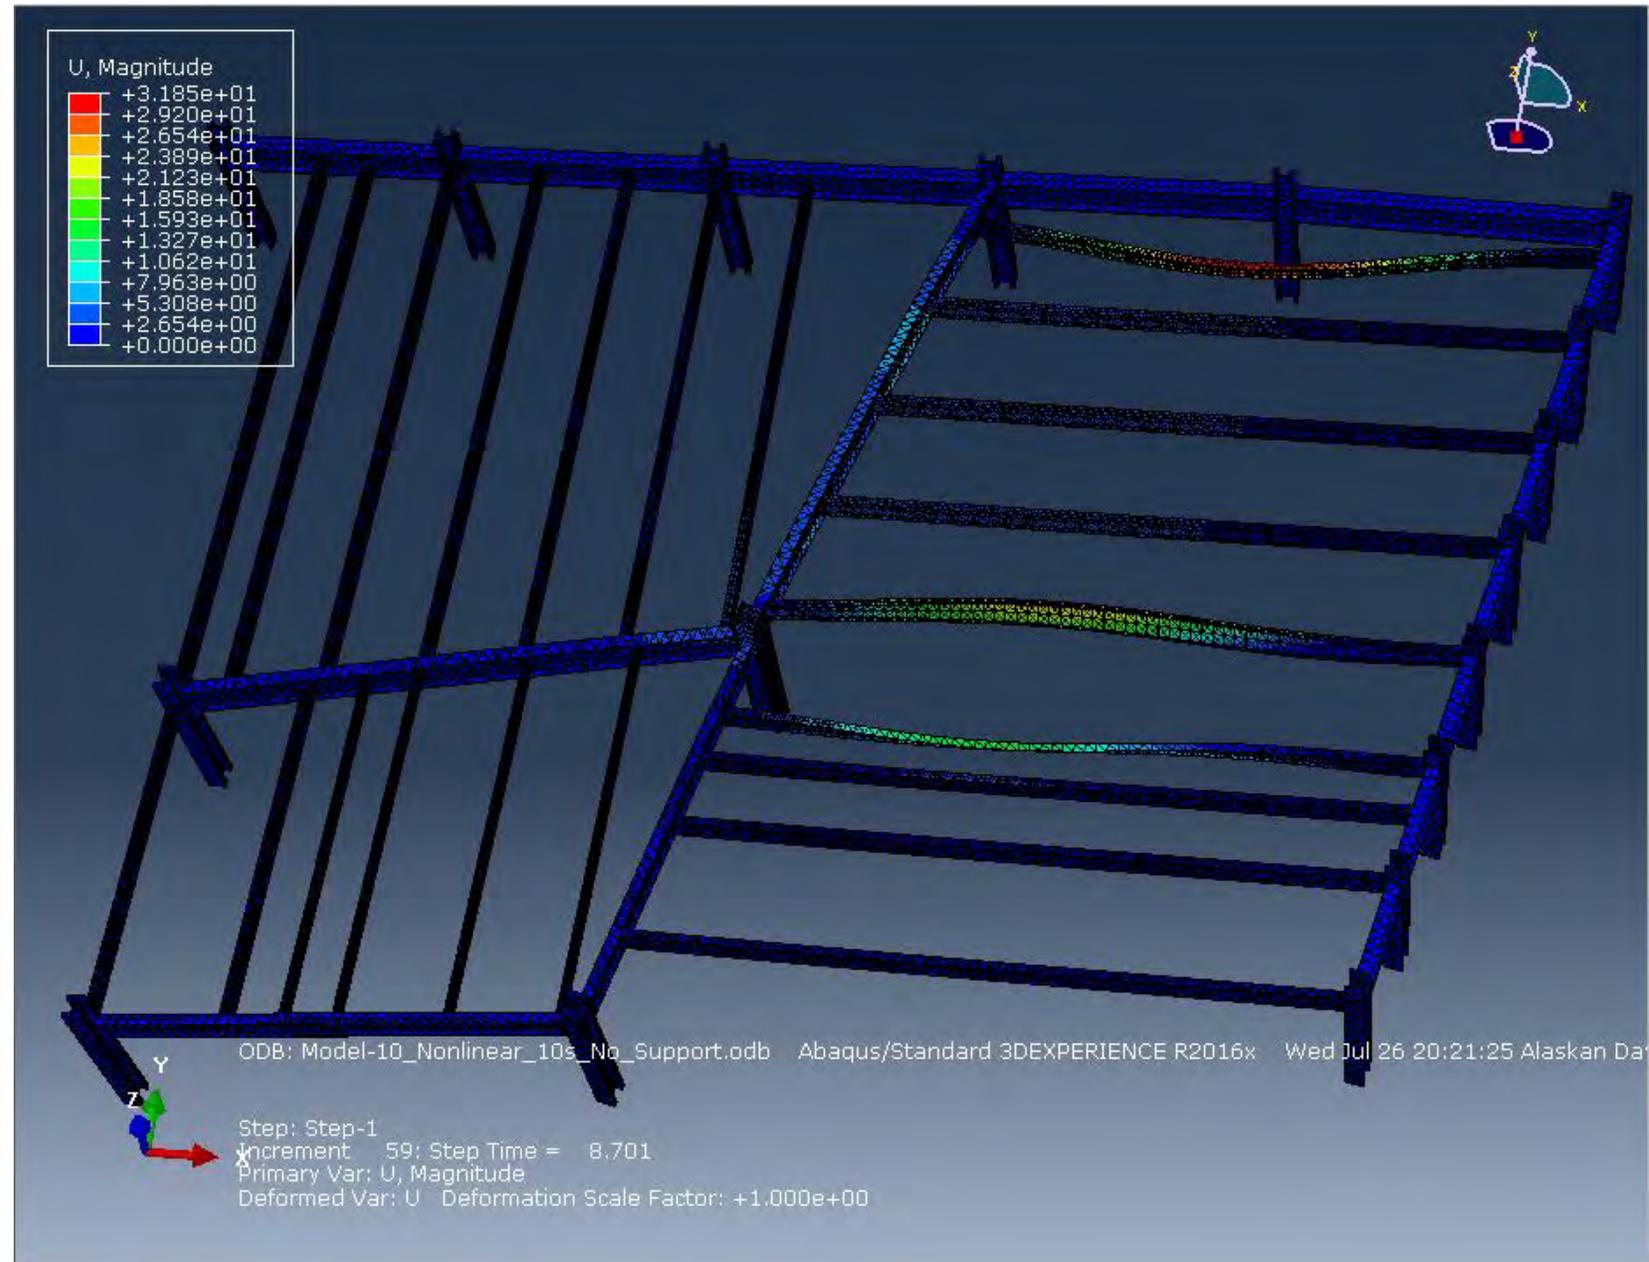
UAF analysis showing beam G3005 does buckle when lateral support beams G3007, K3007, and S3007, spanning to it from the north exterior wall, are not installed.

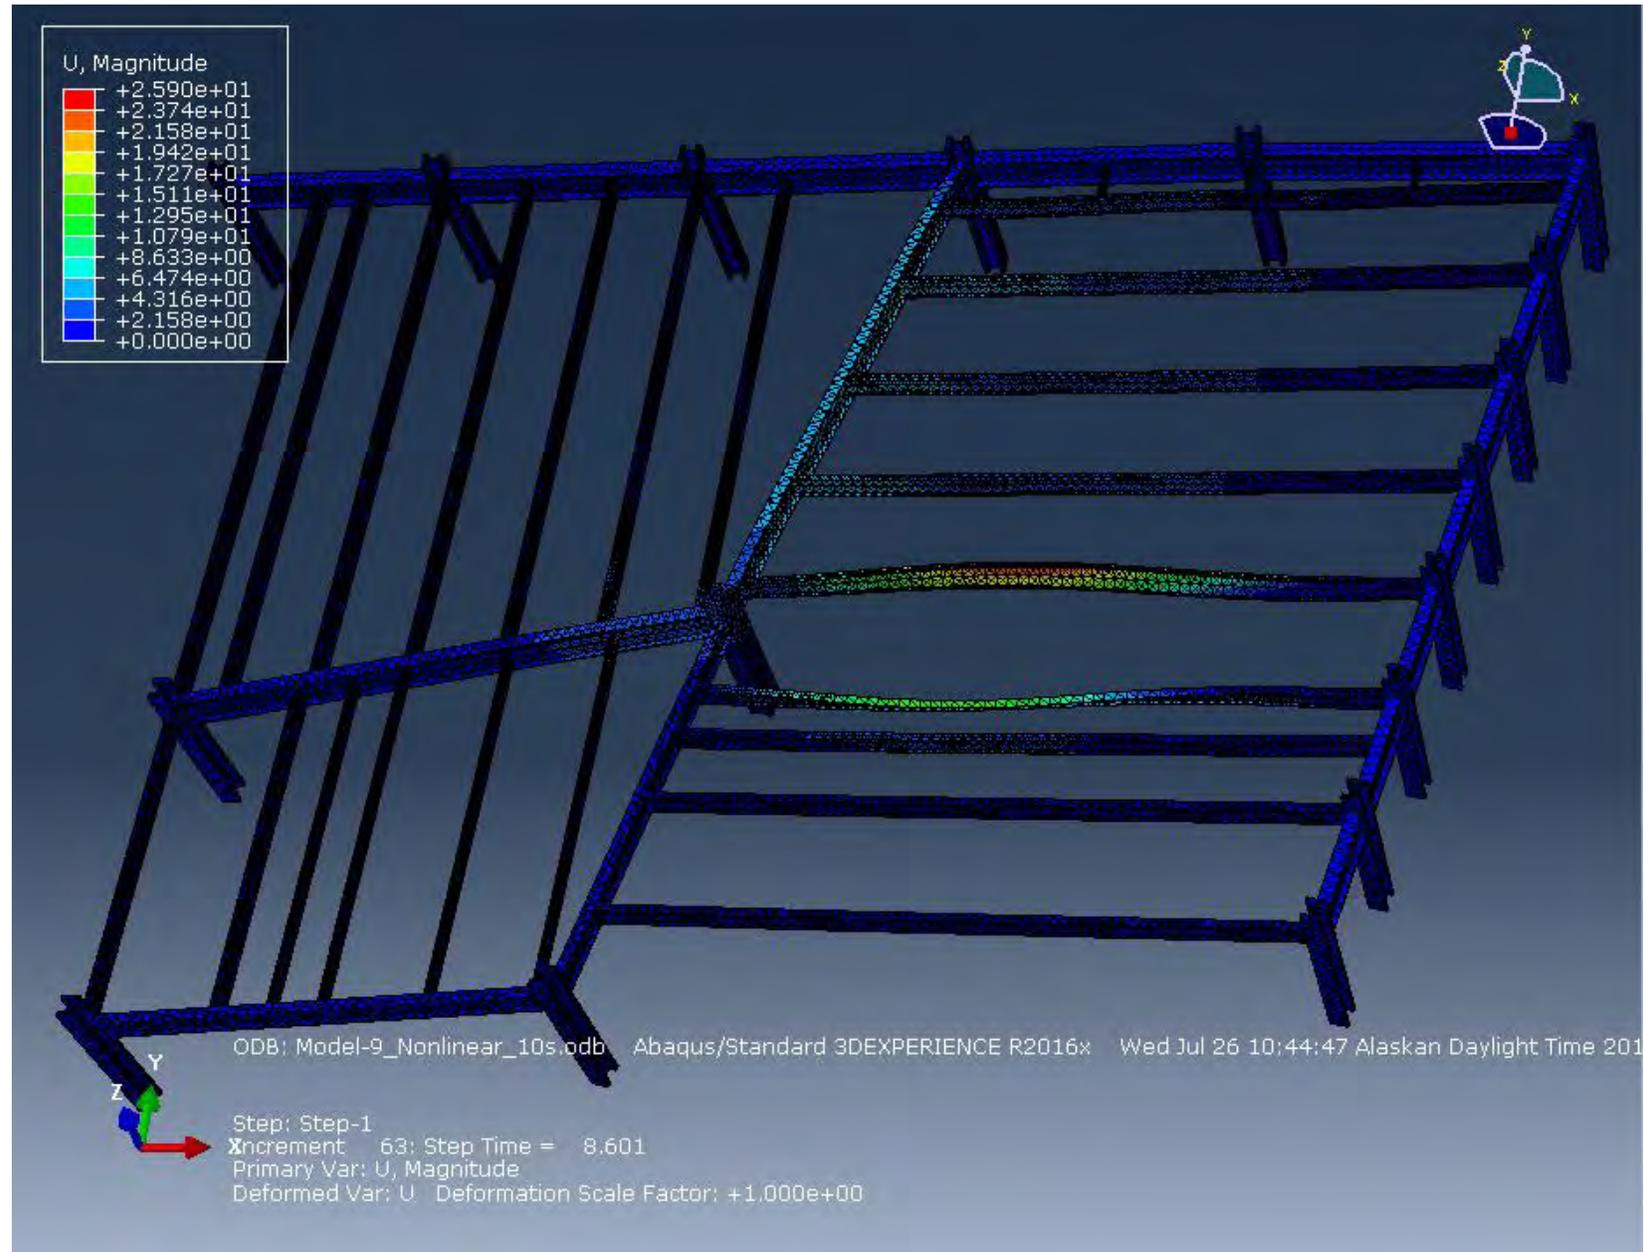
UAF analysis showing beam G3005 does not buckle when lateral support beams S3007, G3007, and K3007, spanning to it from the north exterior wall, are installed.

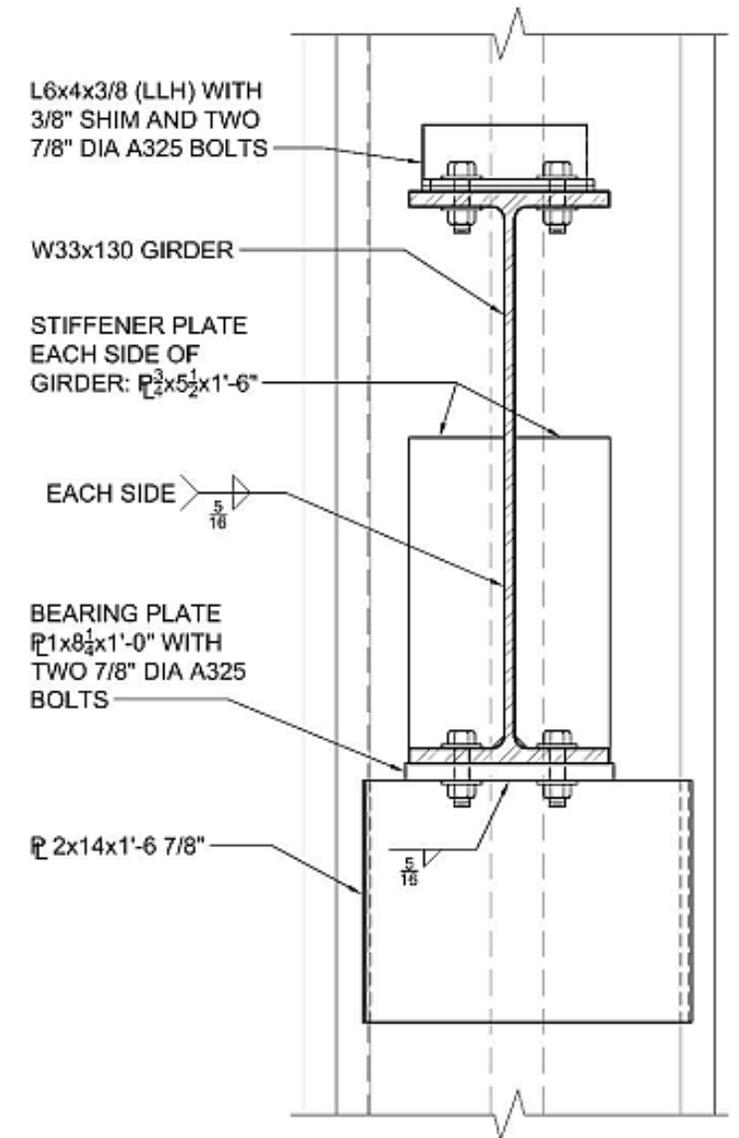
Section view of actual configuration of girder A2001 at its column 79 end from Frankel 1985 drawing 9114, showing its partial height web stiffeners.

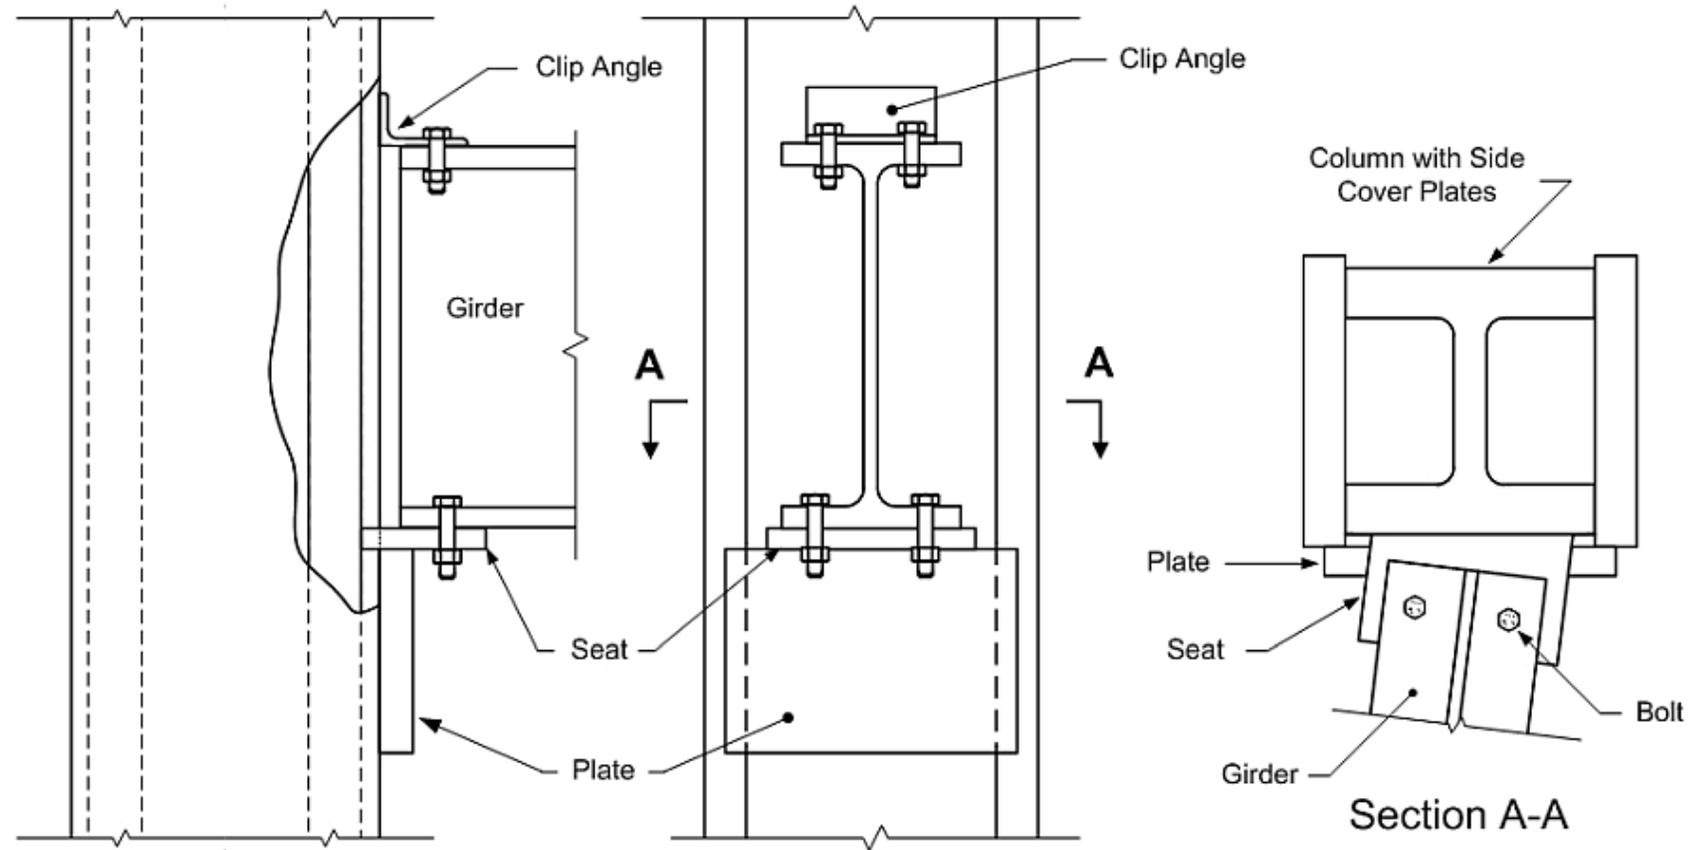
Figure 8-21 from NIST WTC 7 Report

Note: partial height web stiffeners are missing; this is not per Frankel 1985.

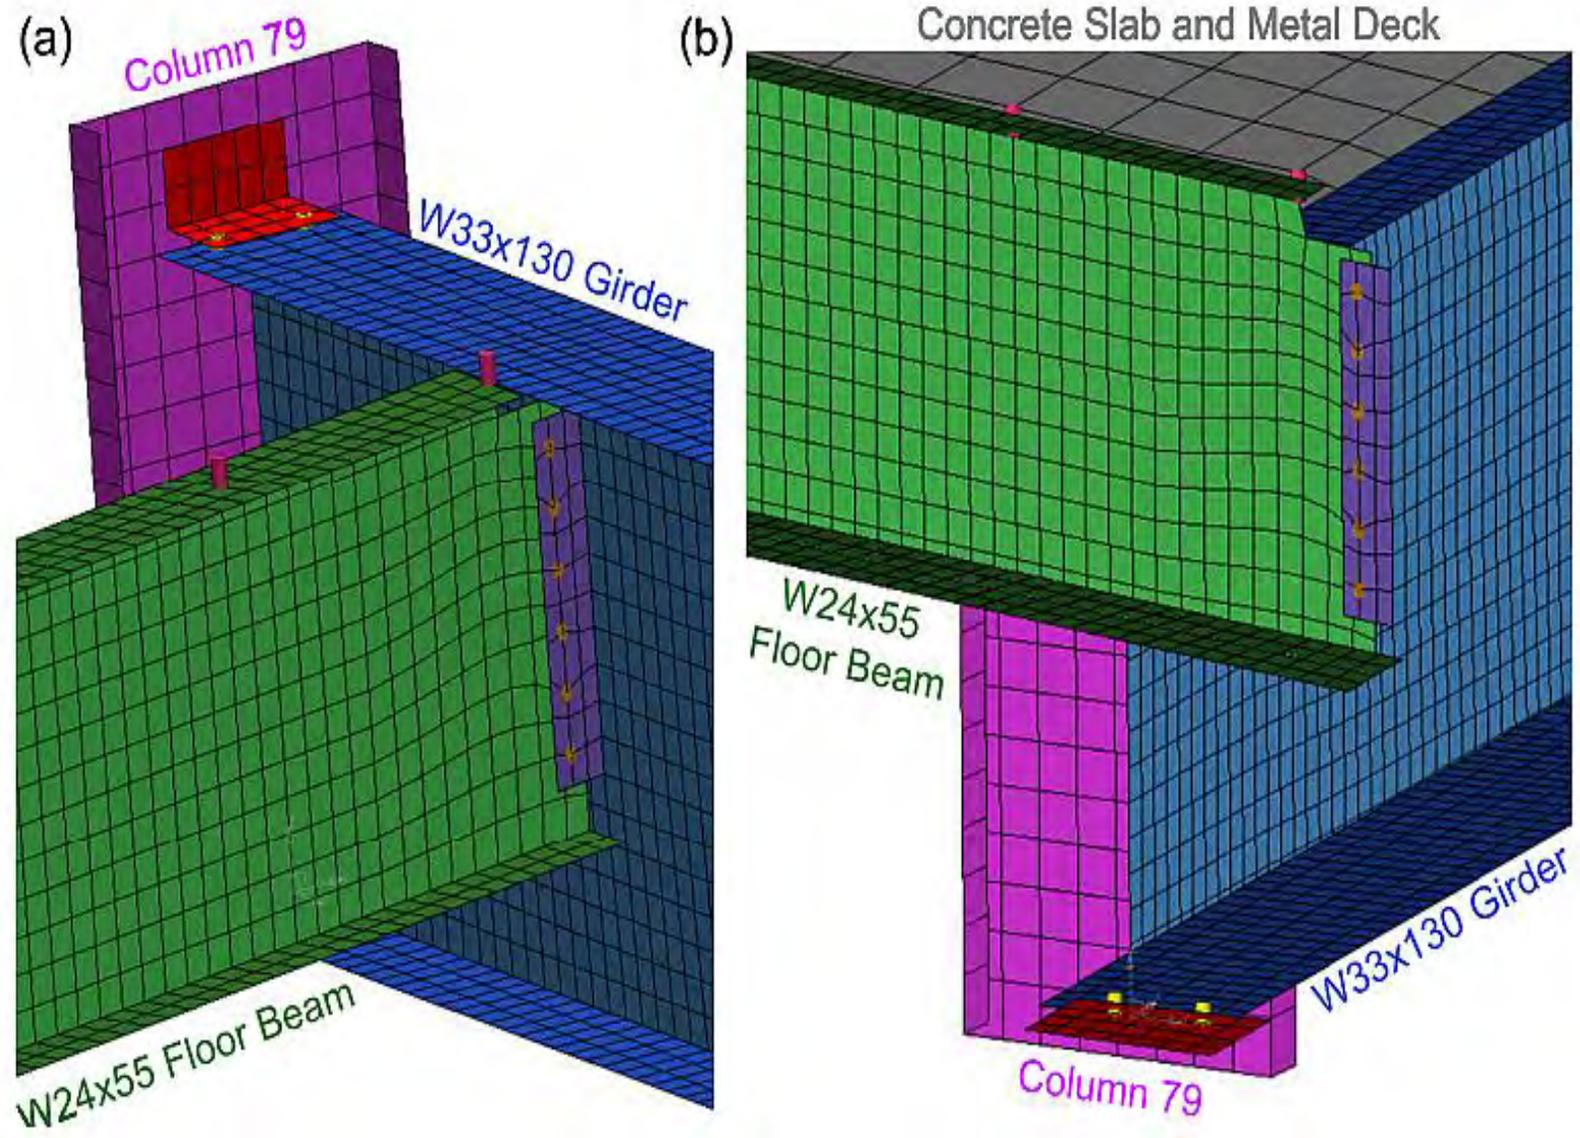
Figure 8-23 finite element analysis model from NIST WTC7 Report

Note: partial height web stiffeners are missing.

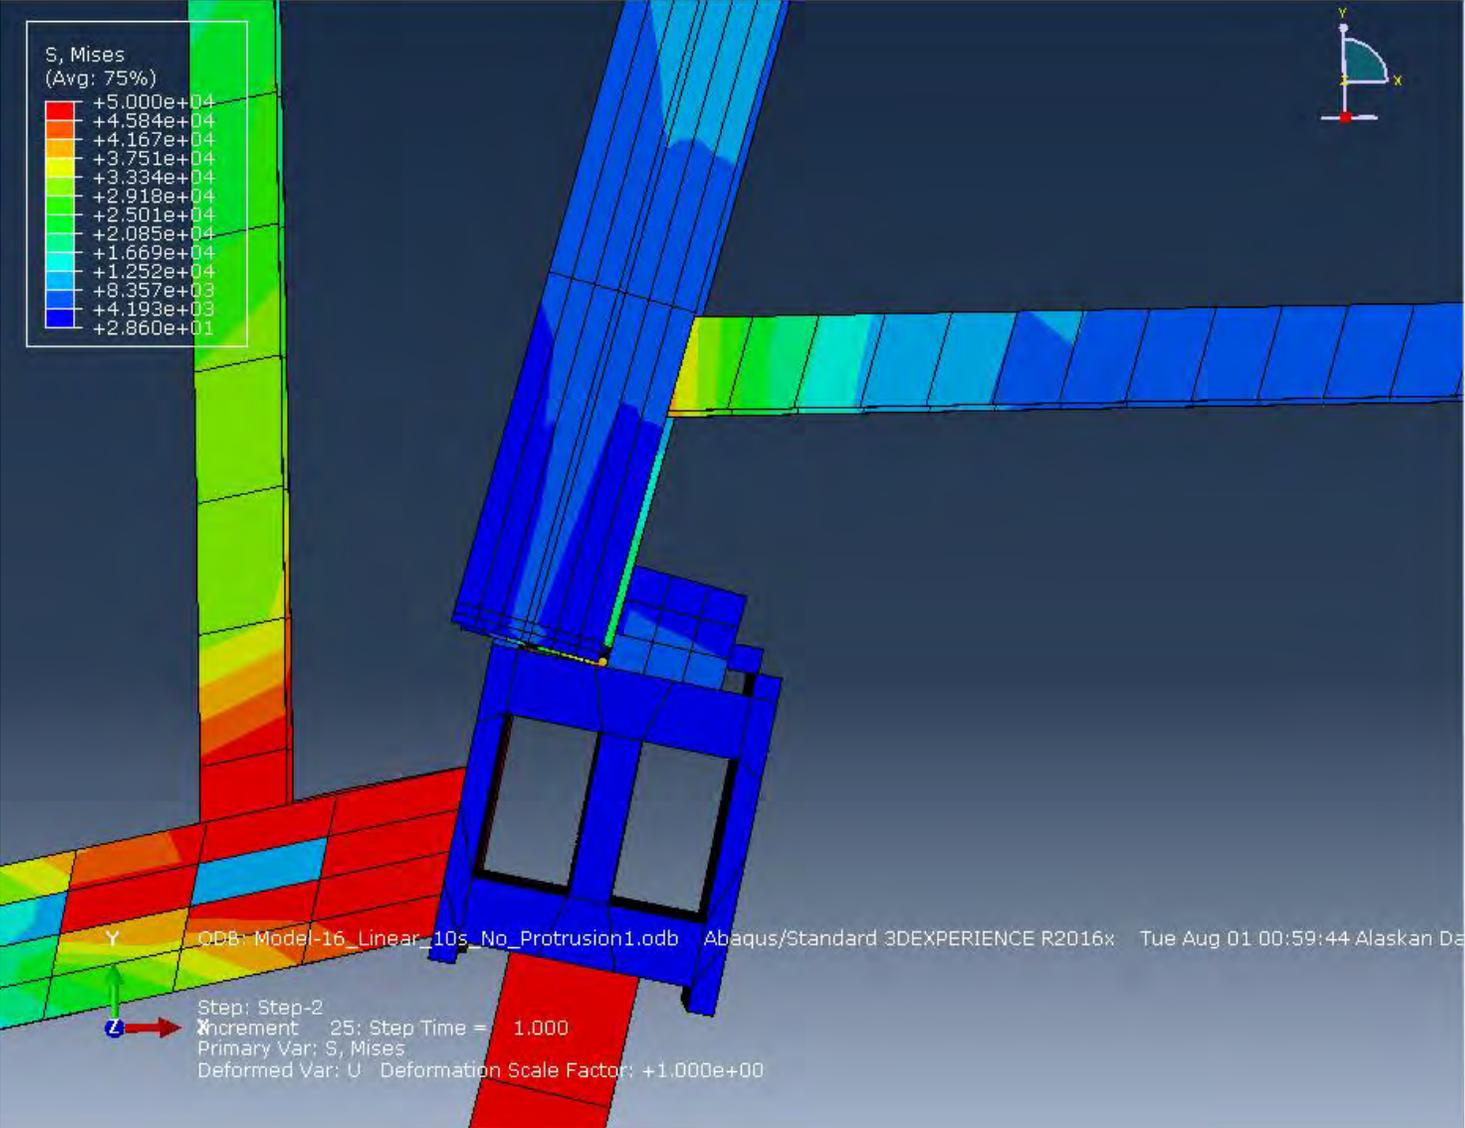
Analysis was performed forcing girder A2001 web beyond its bearing seat by removing the column side plate and increasing the coefficient of thermal expansion of the beams framing into the girder by 40%. Without the increase in the coefficient of thermal expansion the web would not have moved sufficiently to get off the bearing seat.

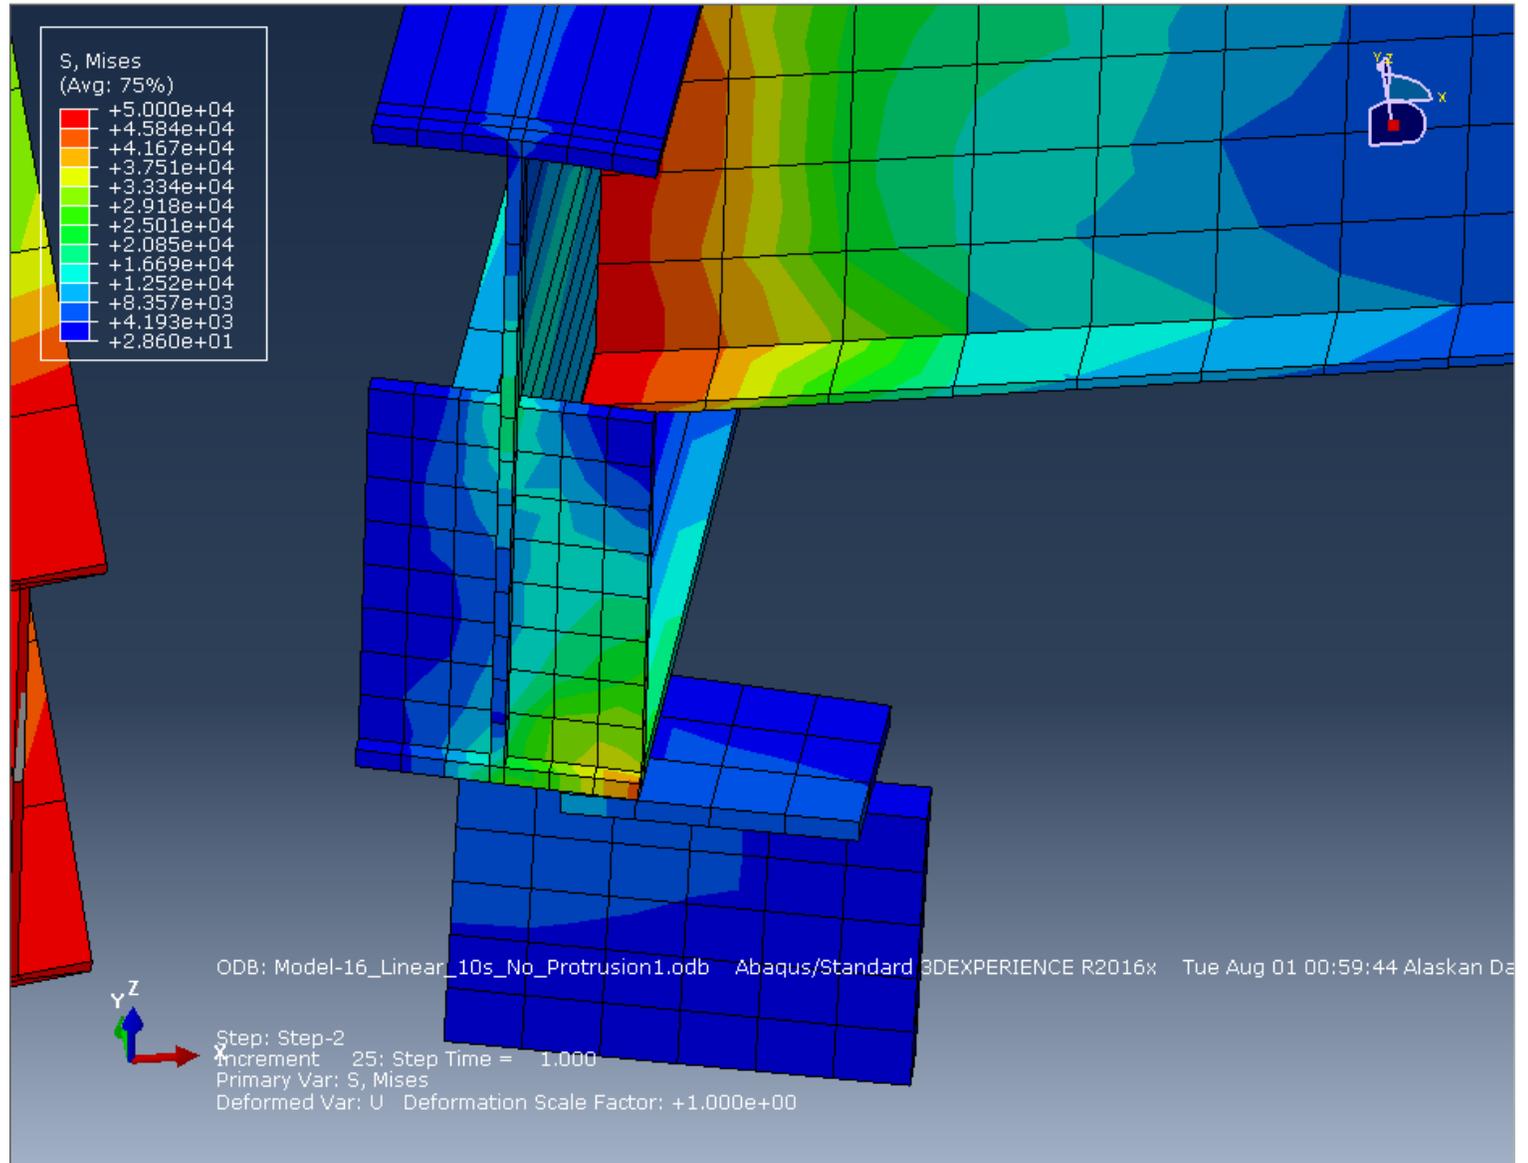
The UAF analysis shows that the girder will not fail with the partial height web stiffeners installed. The small area of high stress is not in the load path and is due to the tip of the girder being compressed against the flange of column 79. This is not a structural concern.

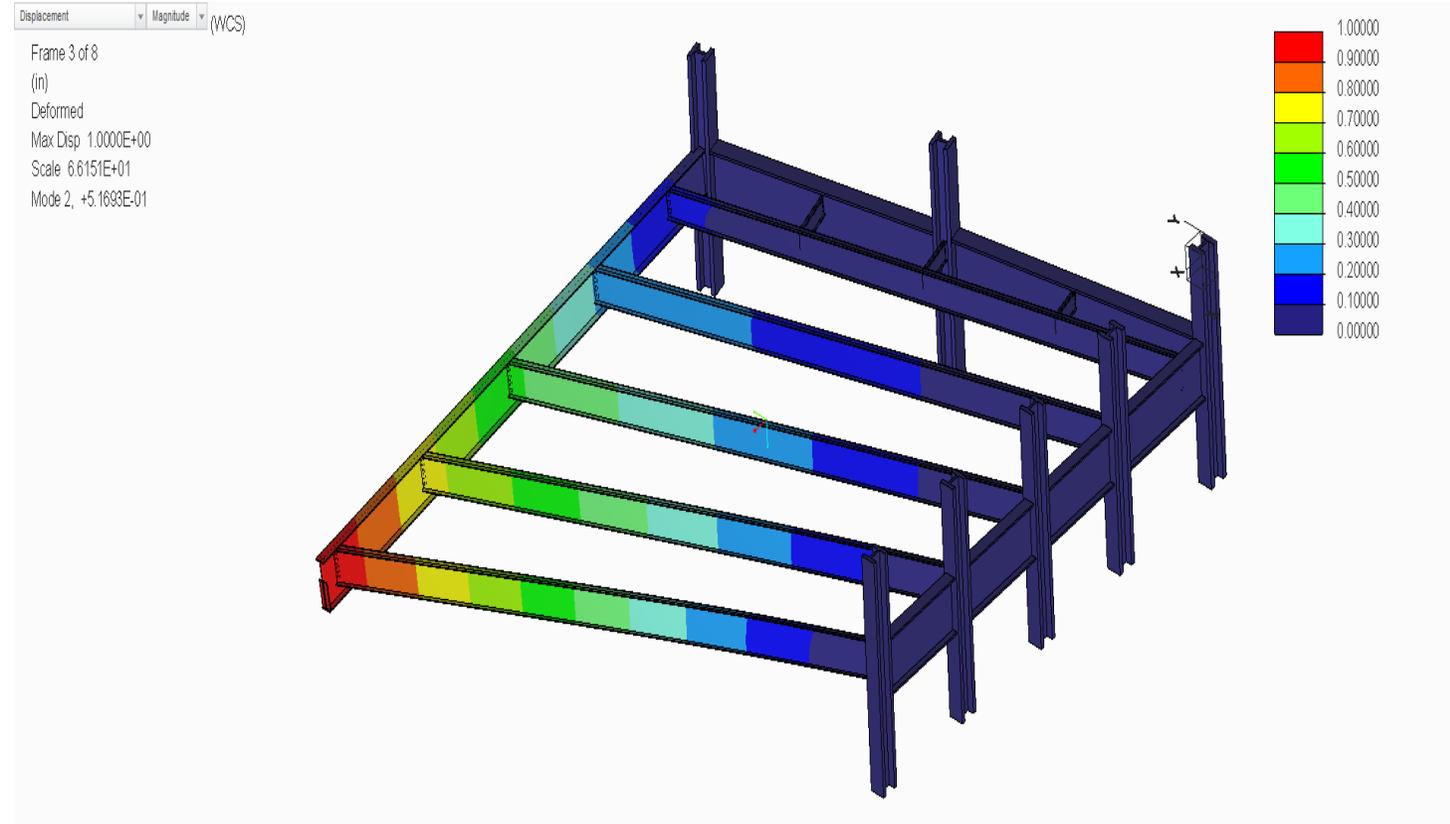
Modal analysis showing 52 Hz frequency mode of the falling beam and girder assembly which was needed to calculate the combined stiffness of the contacting structural members and the subsequent impact load on the girder below on the 12th floor.

Note: NIST & ARUP claimed that the falling beam & girder assembly from floor 13 impacted and broke through floor 12 resulting in an 8 floor cascade.

Based on the natural frequency the stiffness of the beams can be calculated and the amount of deflection and load can be determined. This establishes whether these phenomena could physically occur.

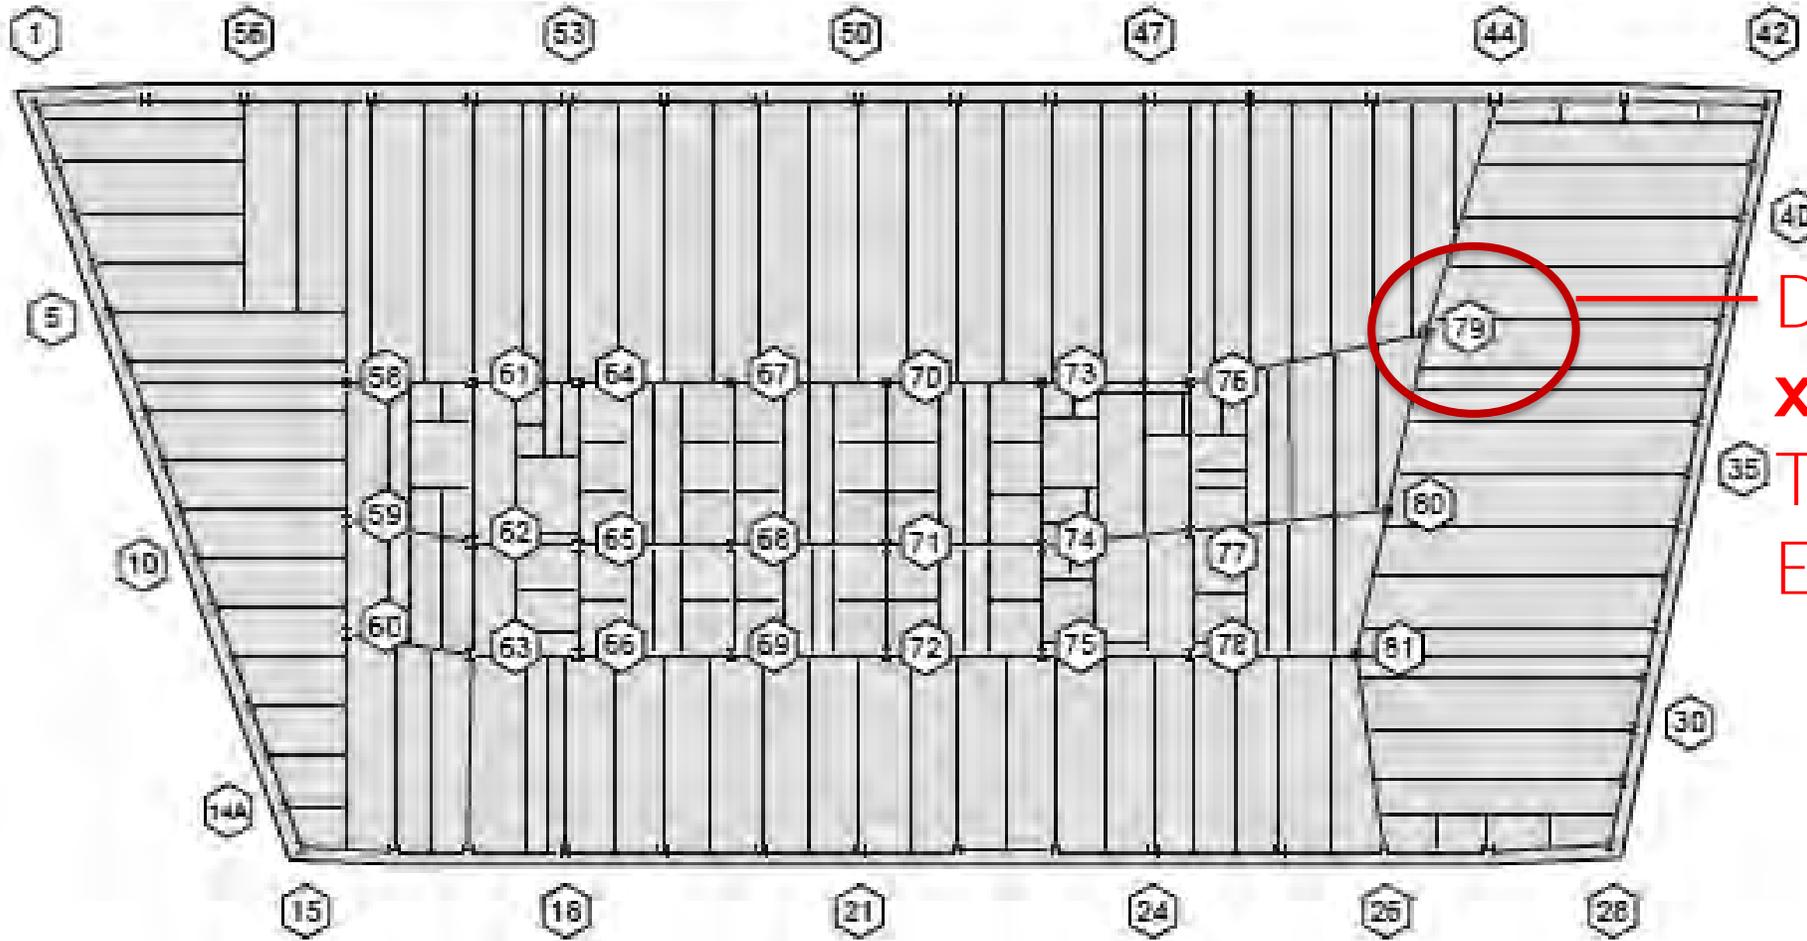
UAF SAP Model: PLAN VIEW – FLOOR 13

DL: 5,142k
x = 1.92"; y = 0.73"
 The floor moved East @ column 79.
