A Structural Reevaluation of the Collapse of World Trade Center 7

September 2017 Progress Report

Dr. J. Leroy Hulsey, Professor

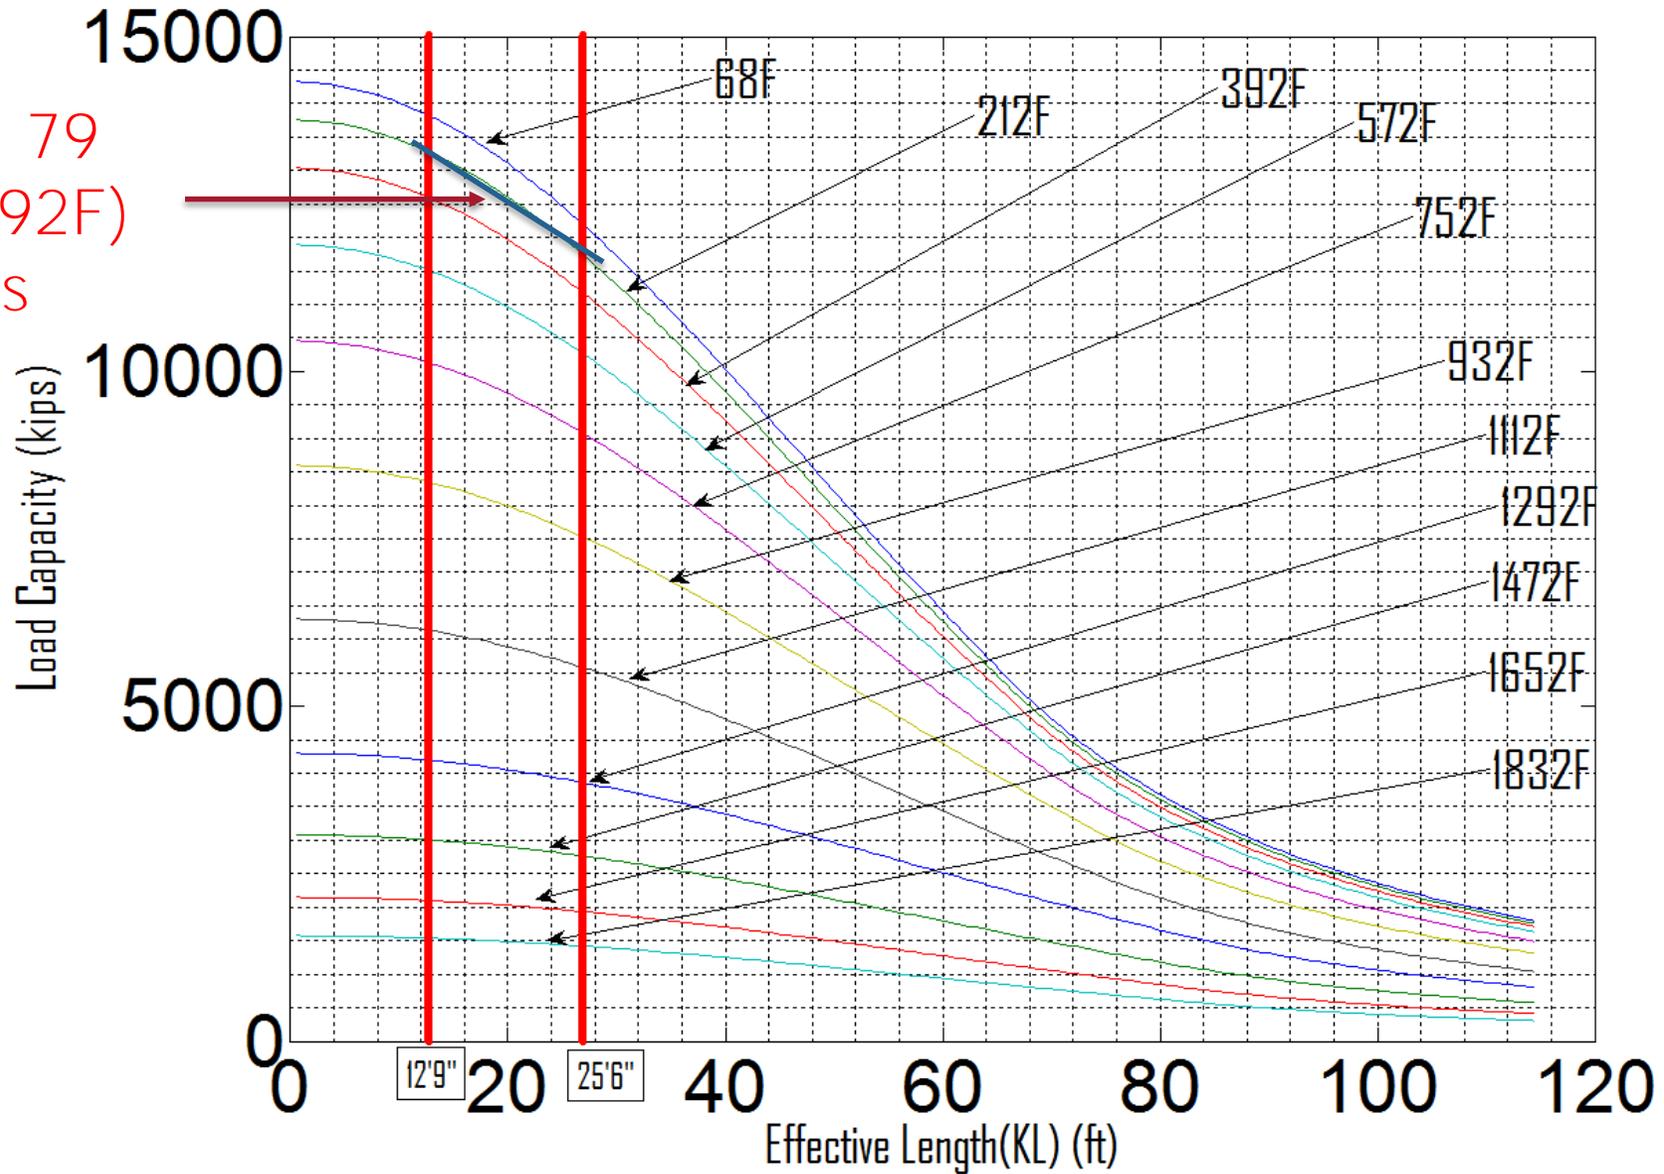
Column 79 Load Capacity (kips) VS Effective Length @ Various Temperatures (LRFD)

NIST Col 79
temp (392F)
All floors

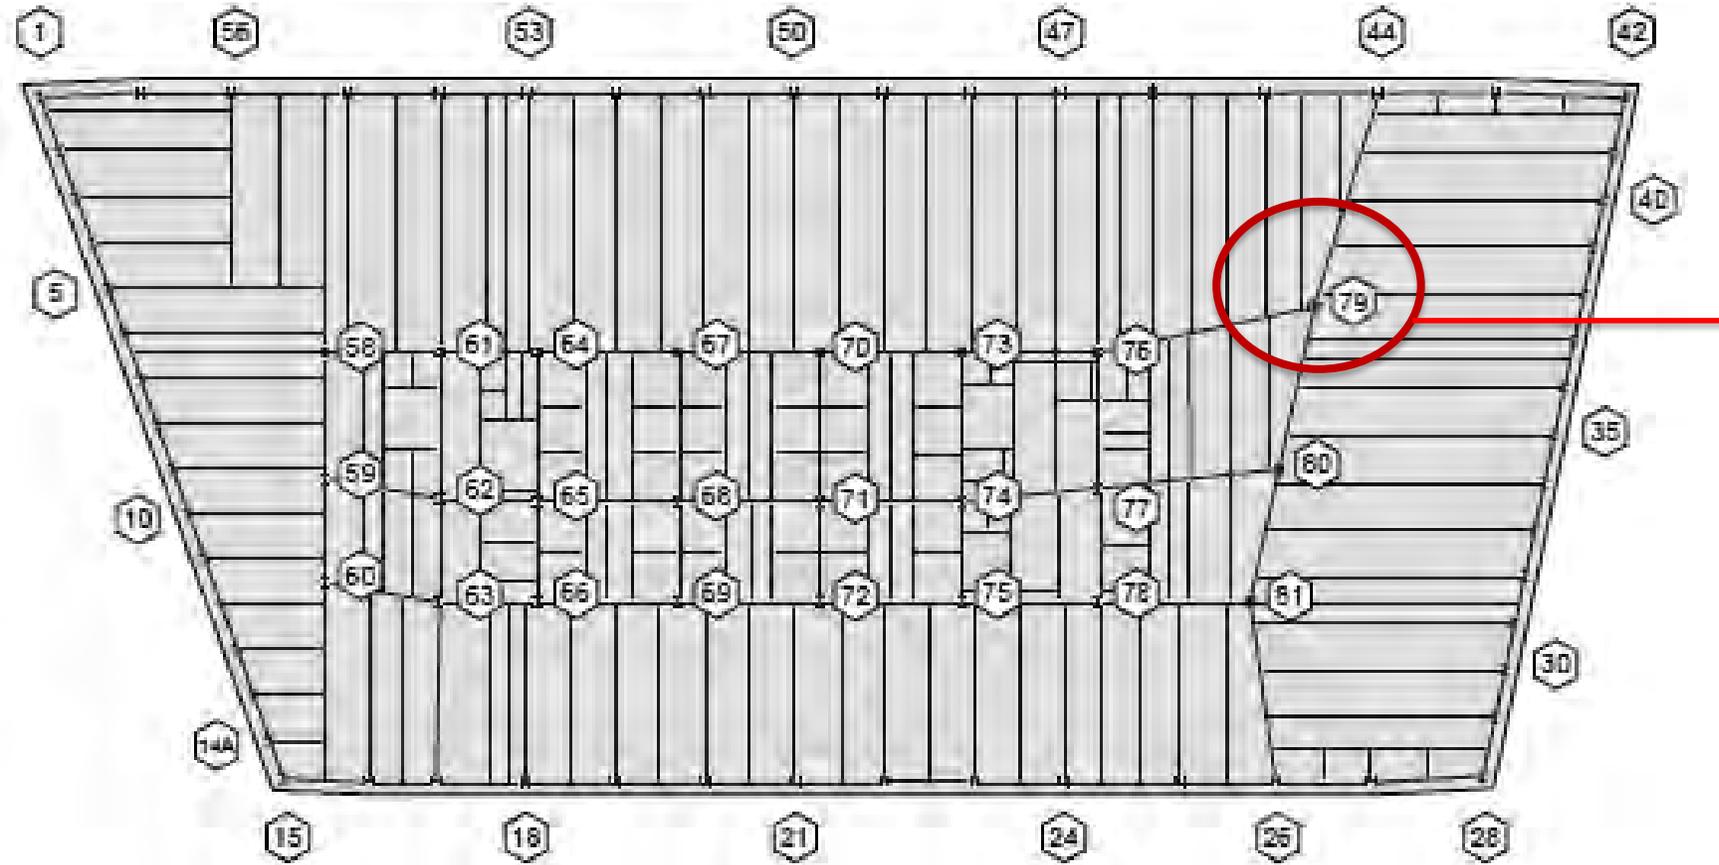
UAF SAP, ABAQUS Models: PLAN VIEW – Column 79; FLOOR 13

SAP:
DL: 5,142k
x = 1.92"; y = 0.73"
→

ABAQUS:
1.85", y = 0.94"
→

NIST:
5.5", Revised: 6.2"
← ←
