# Investigating the Mechanics of Destruction at the Twin Towers on 9/11: The Case for Propelled Demolition

By Wayne H. Coste, PE

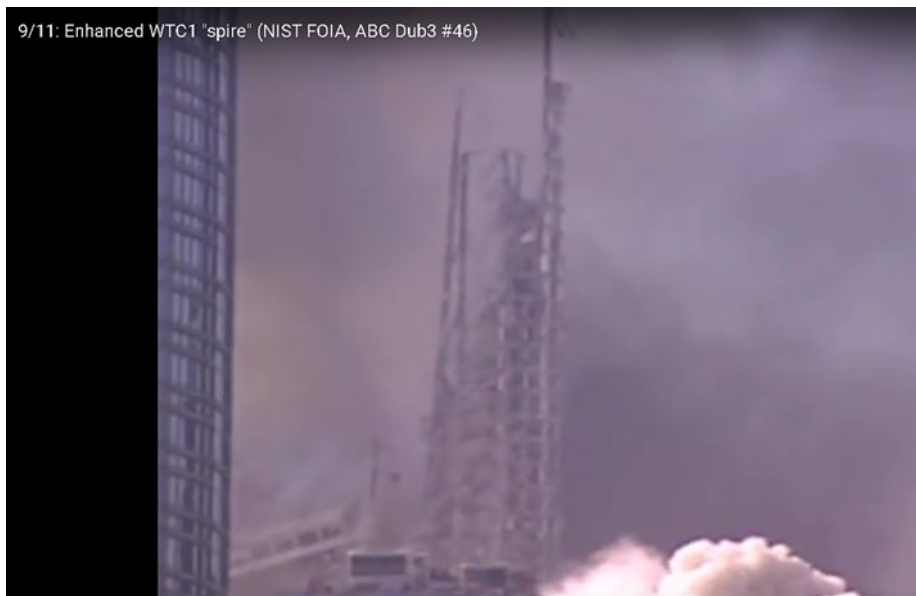
**Figure 6: The "Ghost Spire" consisting of remaining core columns in the immediate aftermath of the destruction of the North Tower**

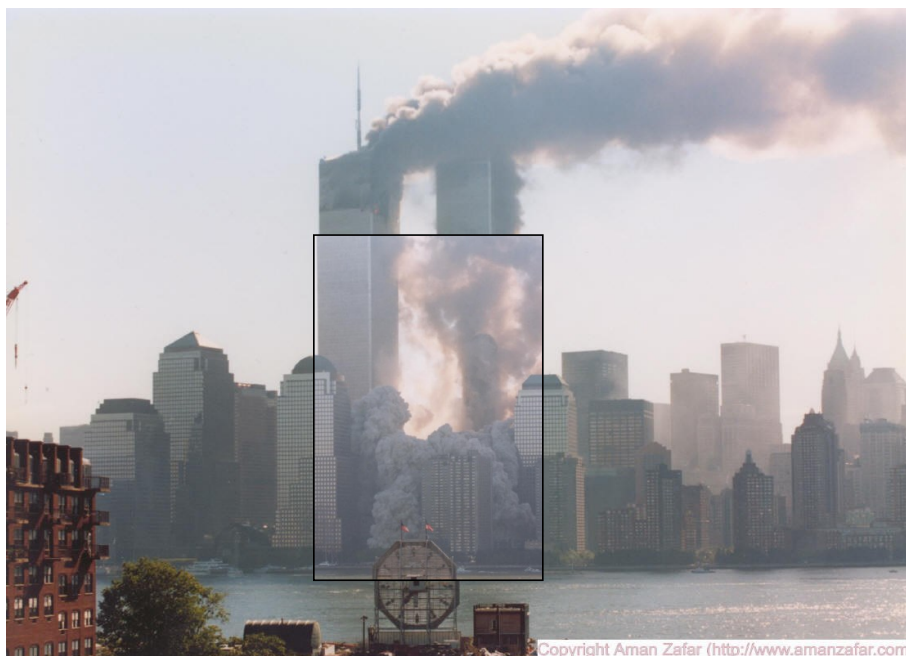
**Figure 7: Remnants of the South Tower core columns remain standing for moments after the surrounding office space is destroyed. (Composite of a pre and post photos by Aman Zafar)**

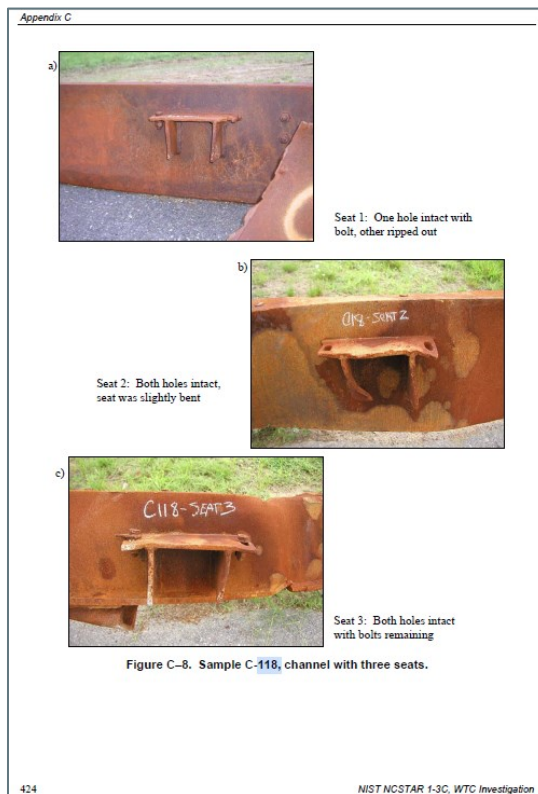
**Figure 22: Truss seat connections on channel steel piece identified as NIST C-118, currently located at River Front Peace Park in Appleton, Newfoundland.**

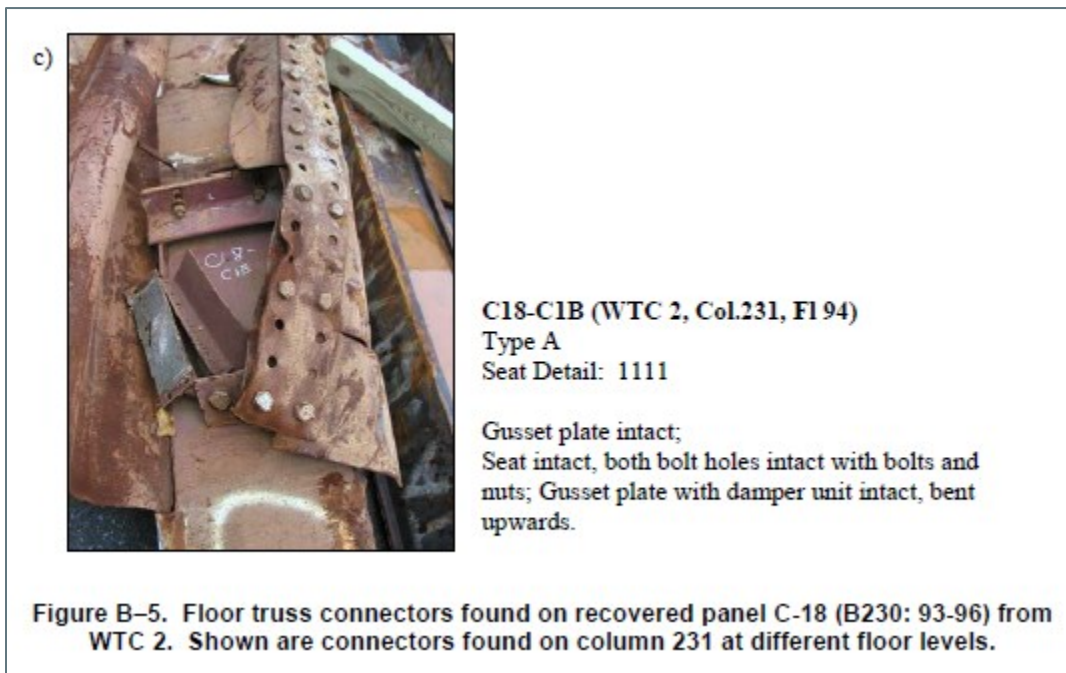
**Figure 23: A perimeter column floor truss connection from floor 94 of the North Tower ("Zone 1") indicates upward acting forces that bend the seat upward as the destruction moves upward.**

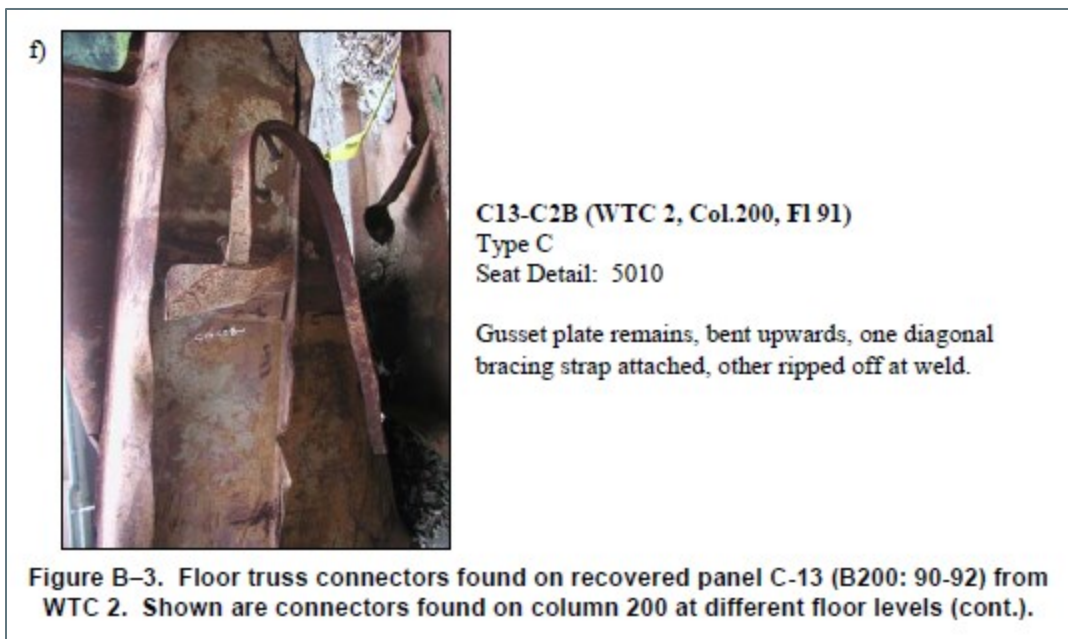
**Figure 24: A perimeter column to floor truss connection from floor 91 of the South Tower ("Zone 1") indicates upward acting forces that bent the seat upward as the destruction moved upward.**

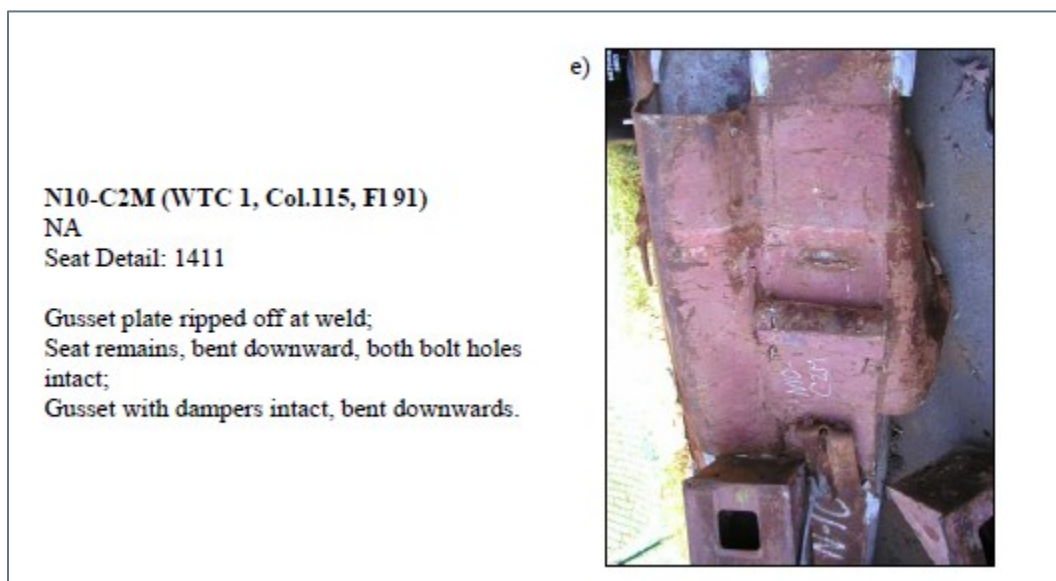
**Figure 25: A perimeter column floor truss connection from floor 91 of the North Tower ("Zone 2") indicates downward acting forces that bend the gusset plate and seat downward based on the geometry of the destruction. (NIST NCSTAR 1-3C, p391)**

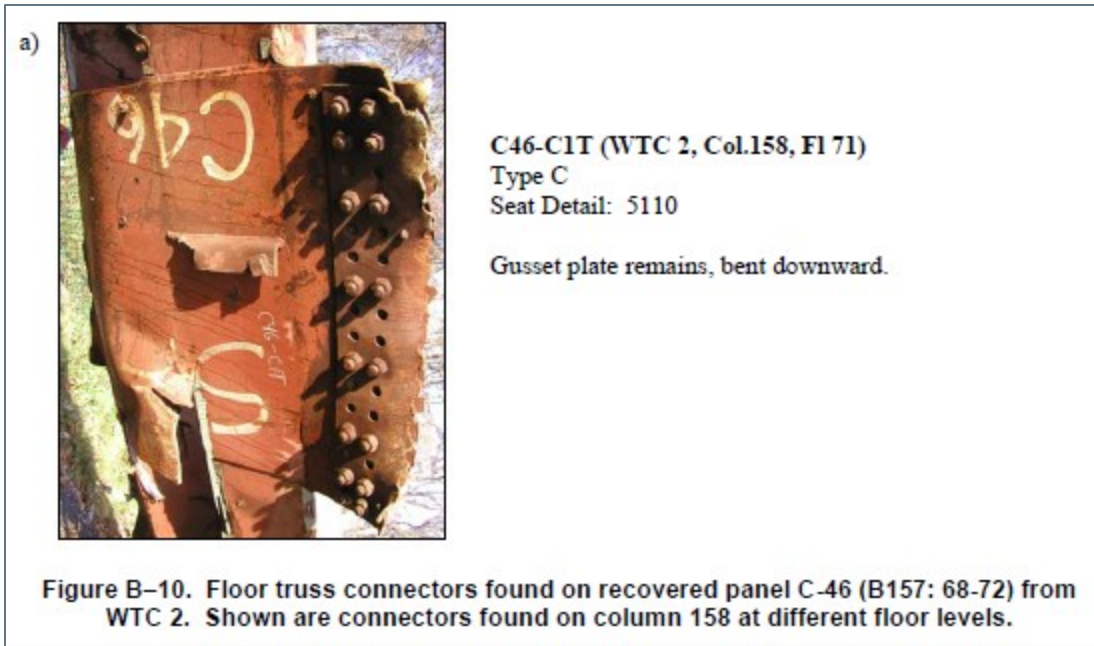
**Figure 26: A perimeter column floor truss connection from floor 71 of the South Tower ("Zone 2") indicates downward acting forces that bend the gusset plate downward based on the geometry of the destruction.**

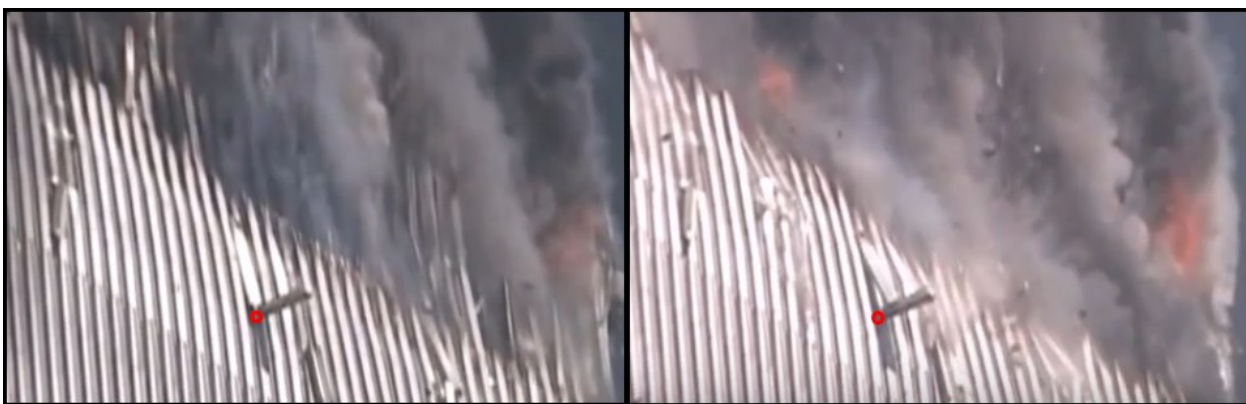
**Figure 33: Push-in of the exterior perimeter columns by the hinged upper block as it begins pivoting/rotating.**

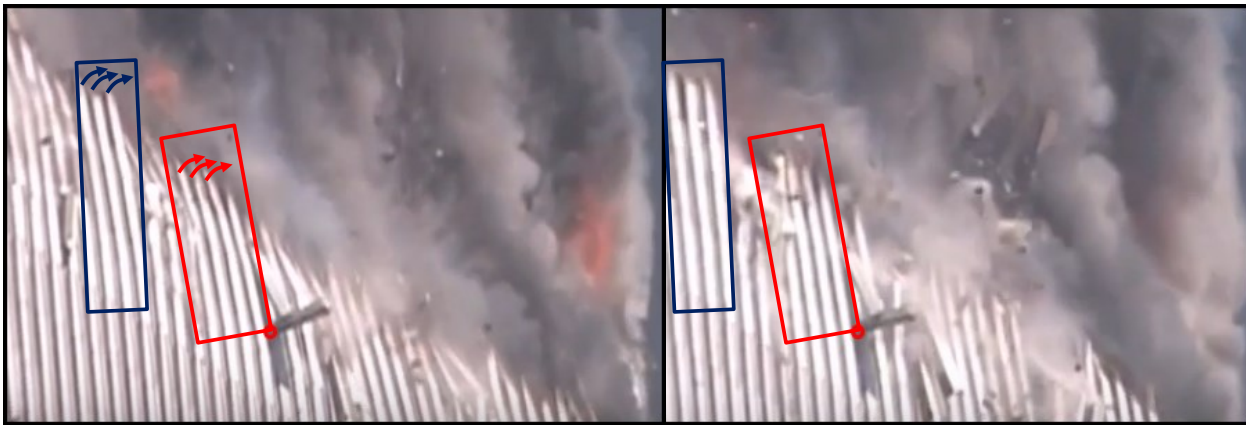
**Figure 34: Rebound of the perimeter column sections after probable connecting bolt failure.**

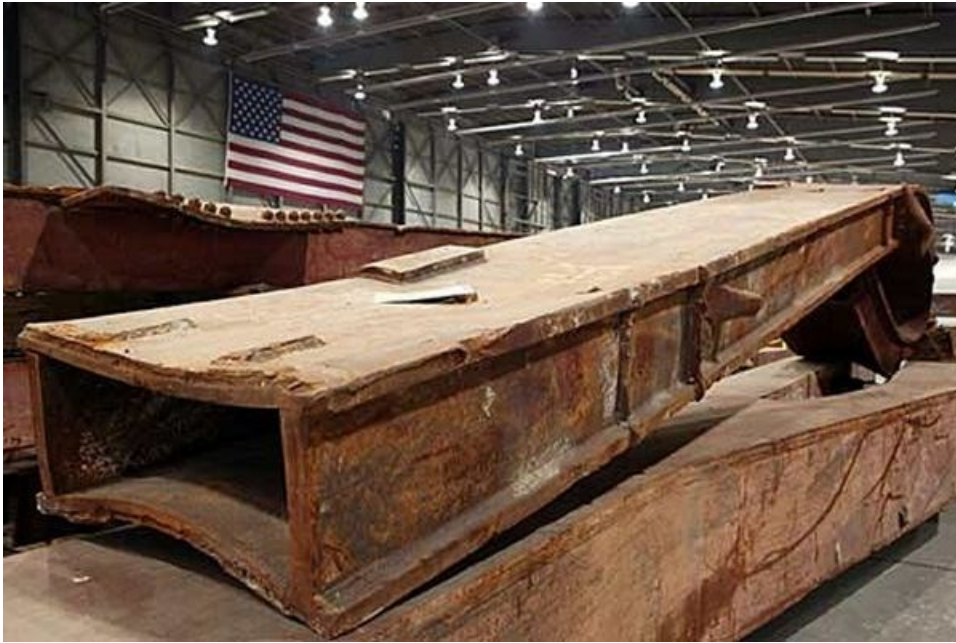
Figure 36: Core column with double concave bends in plates on opposite sides (Photo by Lane Johnson)

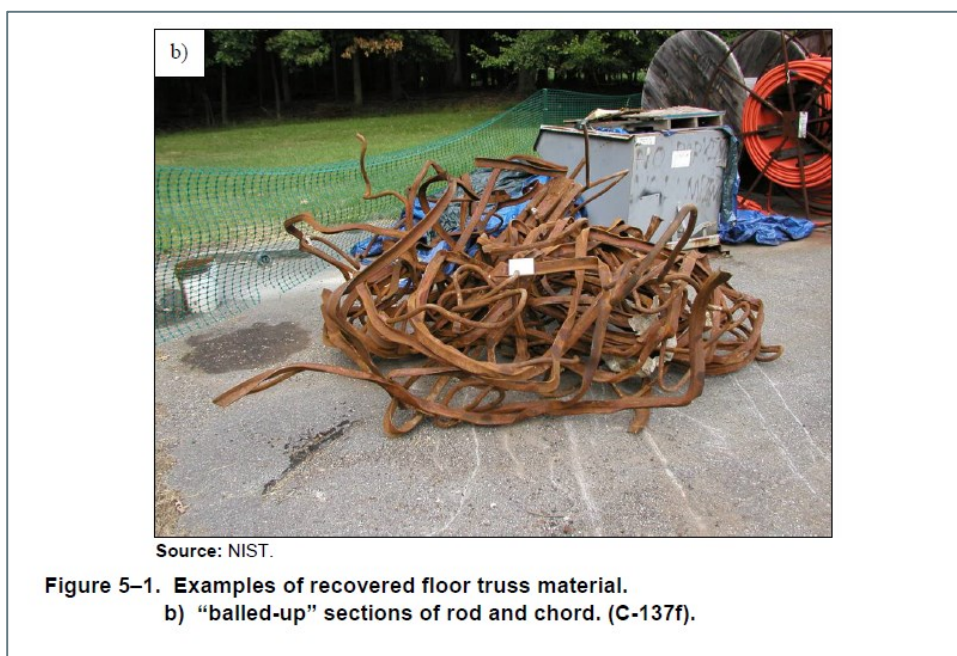
**Figure 38: Remnants of floor truss steel components.**

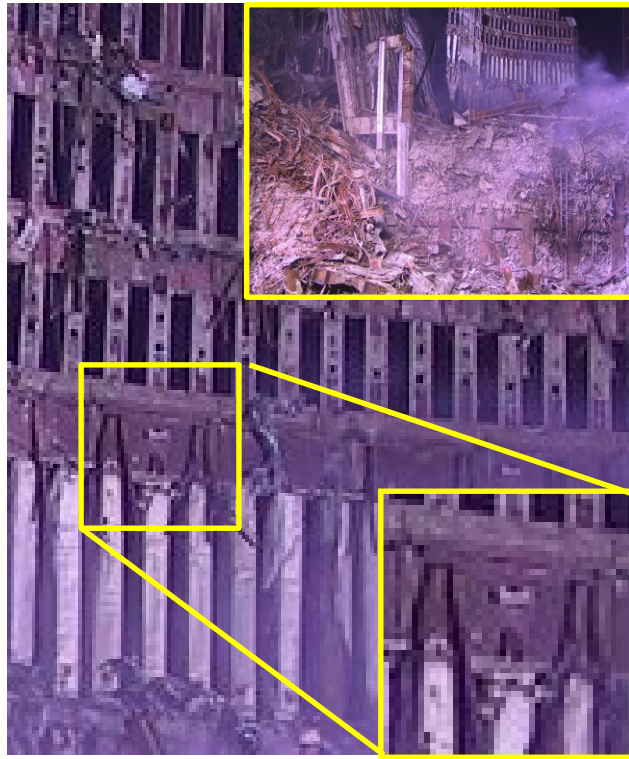
**Figure 46: Inner perimeter columns in "Zone 3" of the North Tower showing hanging floor truss top chords.**

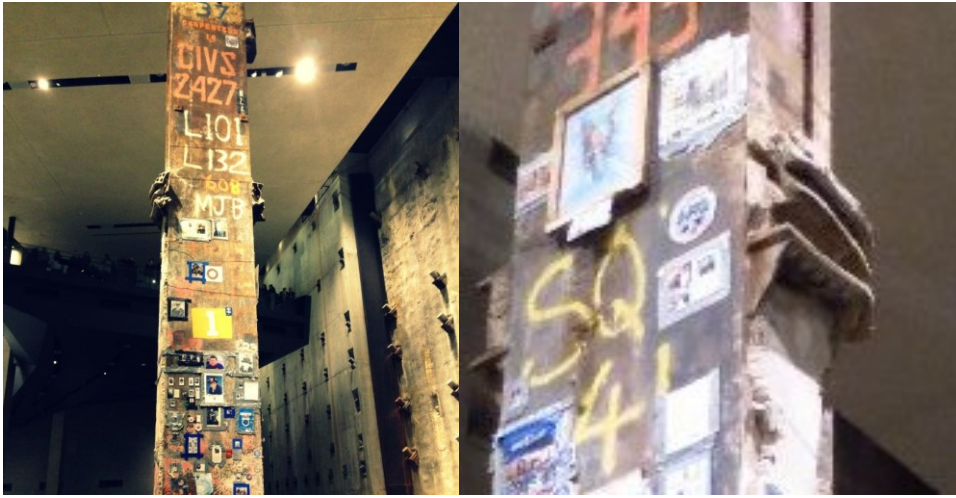
**Figure 47: The "Last Column" was from the lowest level in the basement and shows the downward bend in a seat caused by falling debris that is characteristic of "Zone 3" damage.**

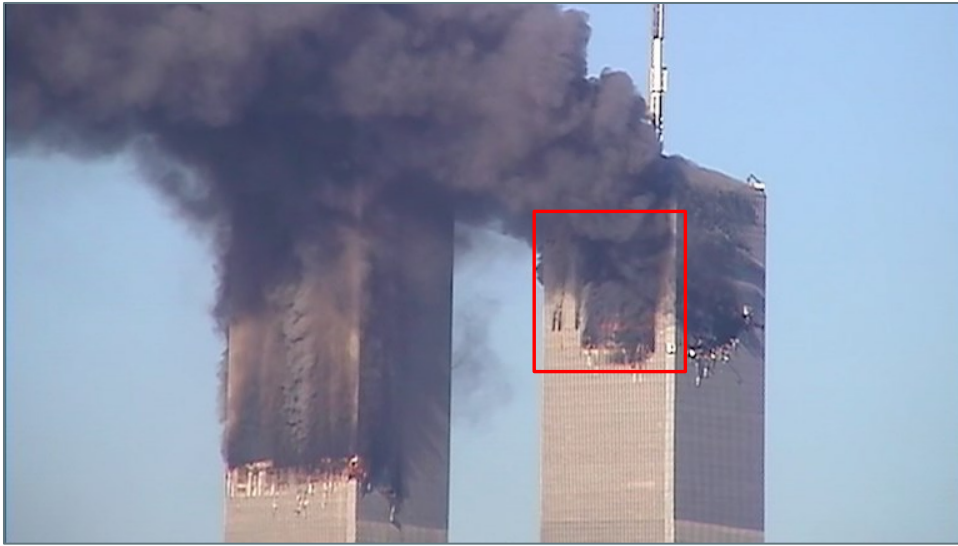
**Figure 56: Relatively clear image of the eviscerated perimeter columns and missing floors in the area perpendicular to the core columns.**

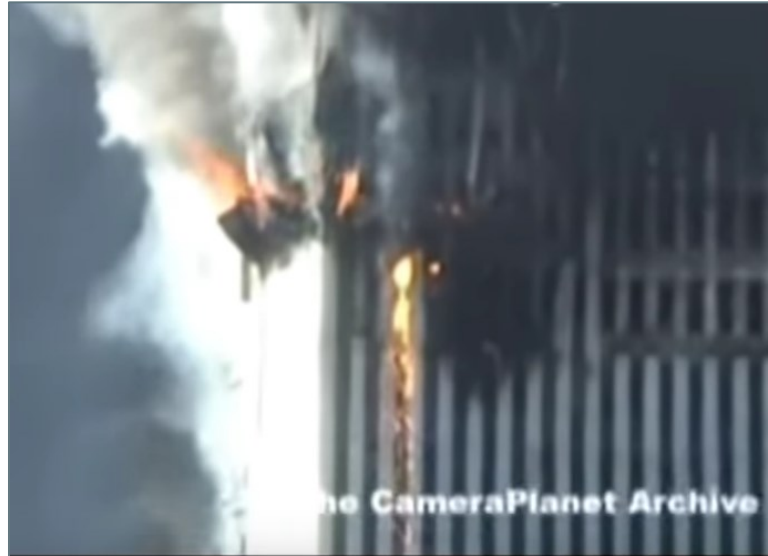
**Figure 57: Molten iron streaming out of the South Tower shortly before the demolition began.**
