A Structural Reevaluation of the Collapse of World Trade Center 7

September 2017 Progress Report

Dr. J. Leroy Hulsey, Professor

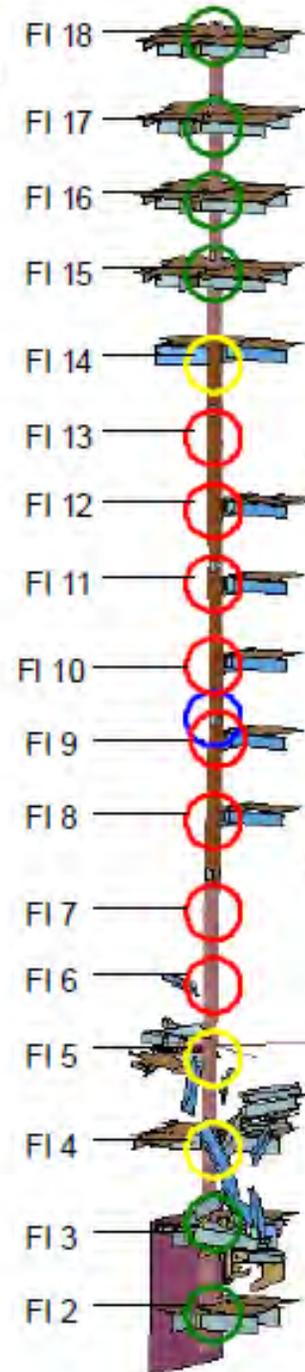
Column 79
at
-1.3 (14.7) s

Column 79:

Loss of lateral support for 9 stories (Floors 6 to 13) caused buckling to initiate.

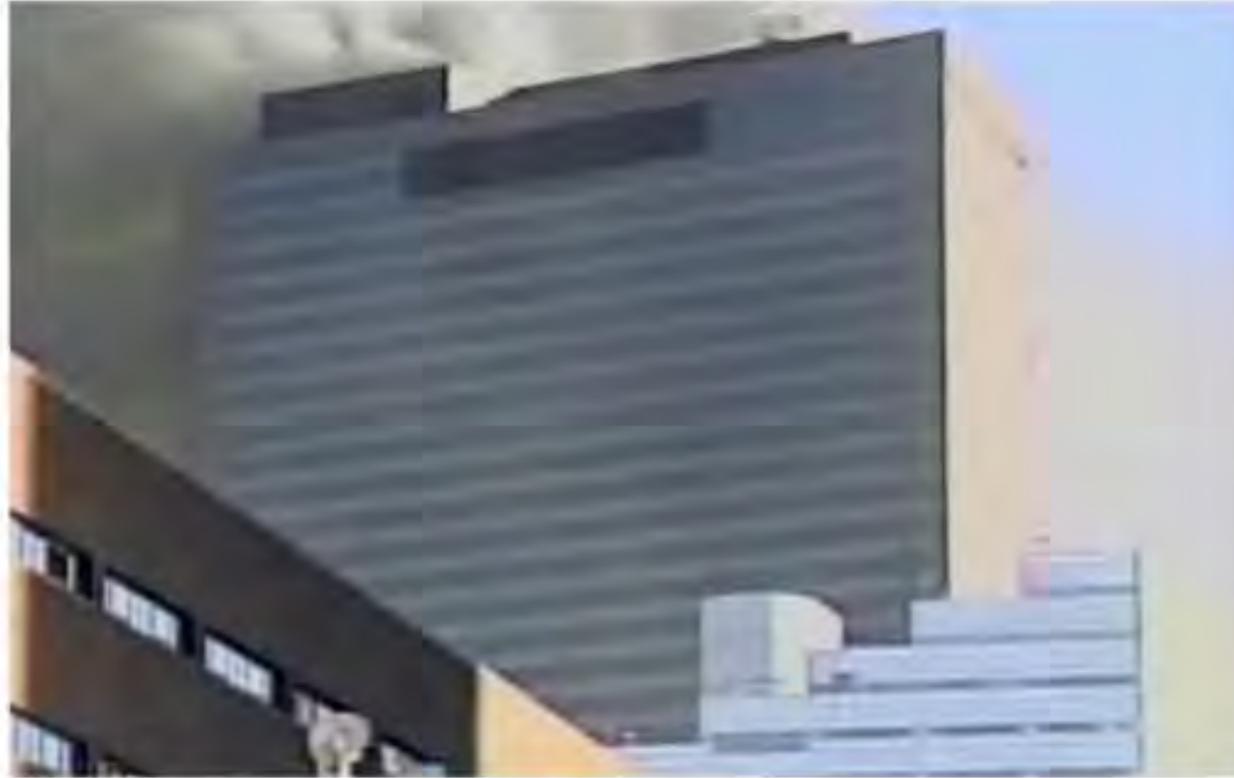
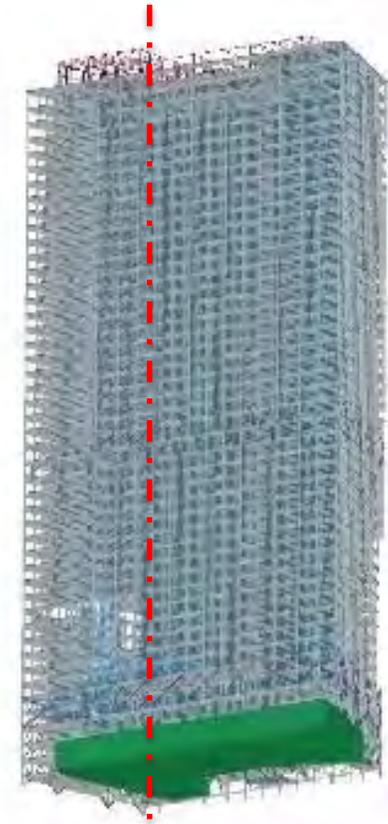
Video vs. NIST WTC7 collapse animation comparison

No exterior column deformation is evident in the actual collapse. Deformation is seen in the NIST model.

Connections were not modeled; outside selected blue space.

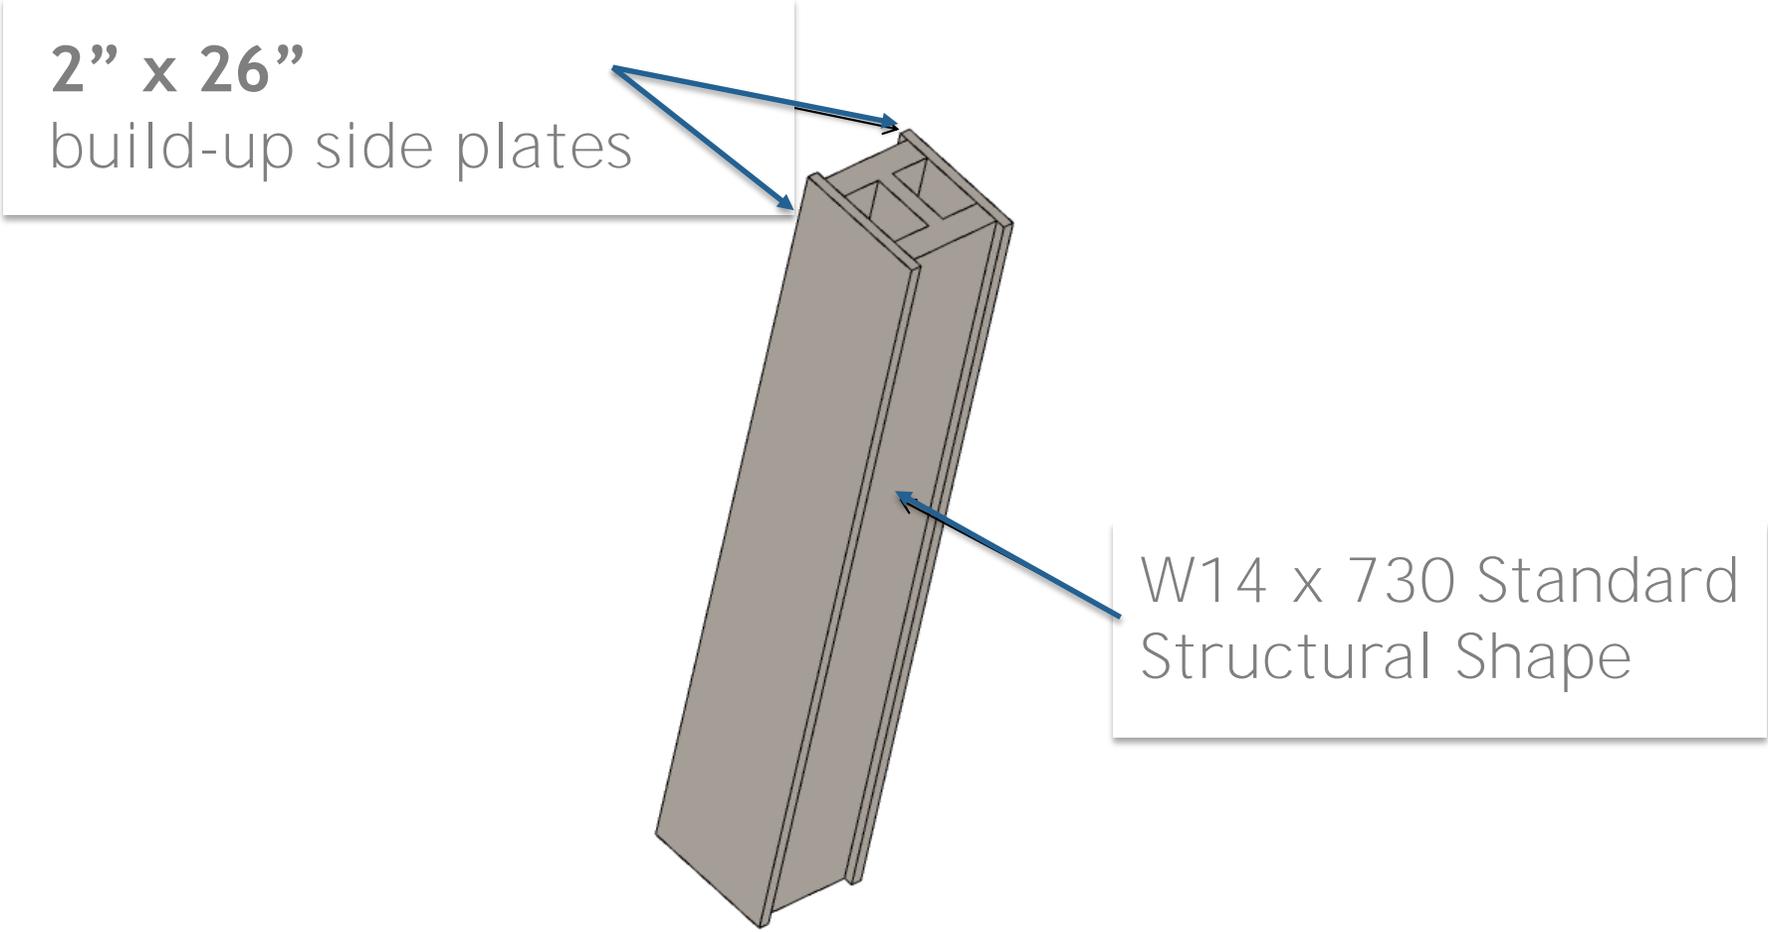
PLAN VIEW OF GIRDER A2001 CONNECTION TO COLUMN 79

Section of Column 79 (showing side plates)

Plan View of girder A2001 moving across its bearing seat at column 79 due to thermal expansion of the beams framing into the girder from the east.

Note: This picture illustrates that A2001 is trapped by the column side plate and it is not possible for it to move the girder web beyond the seat as claimed by NIST.

It appears that NIST did not examine the side plate influence on the restriction of movement by the girder.

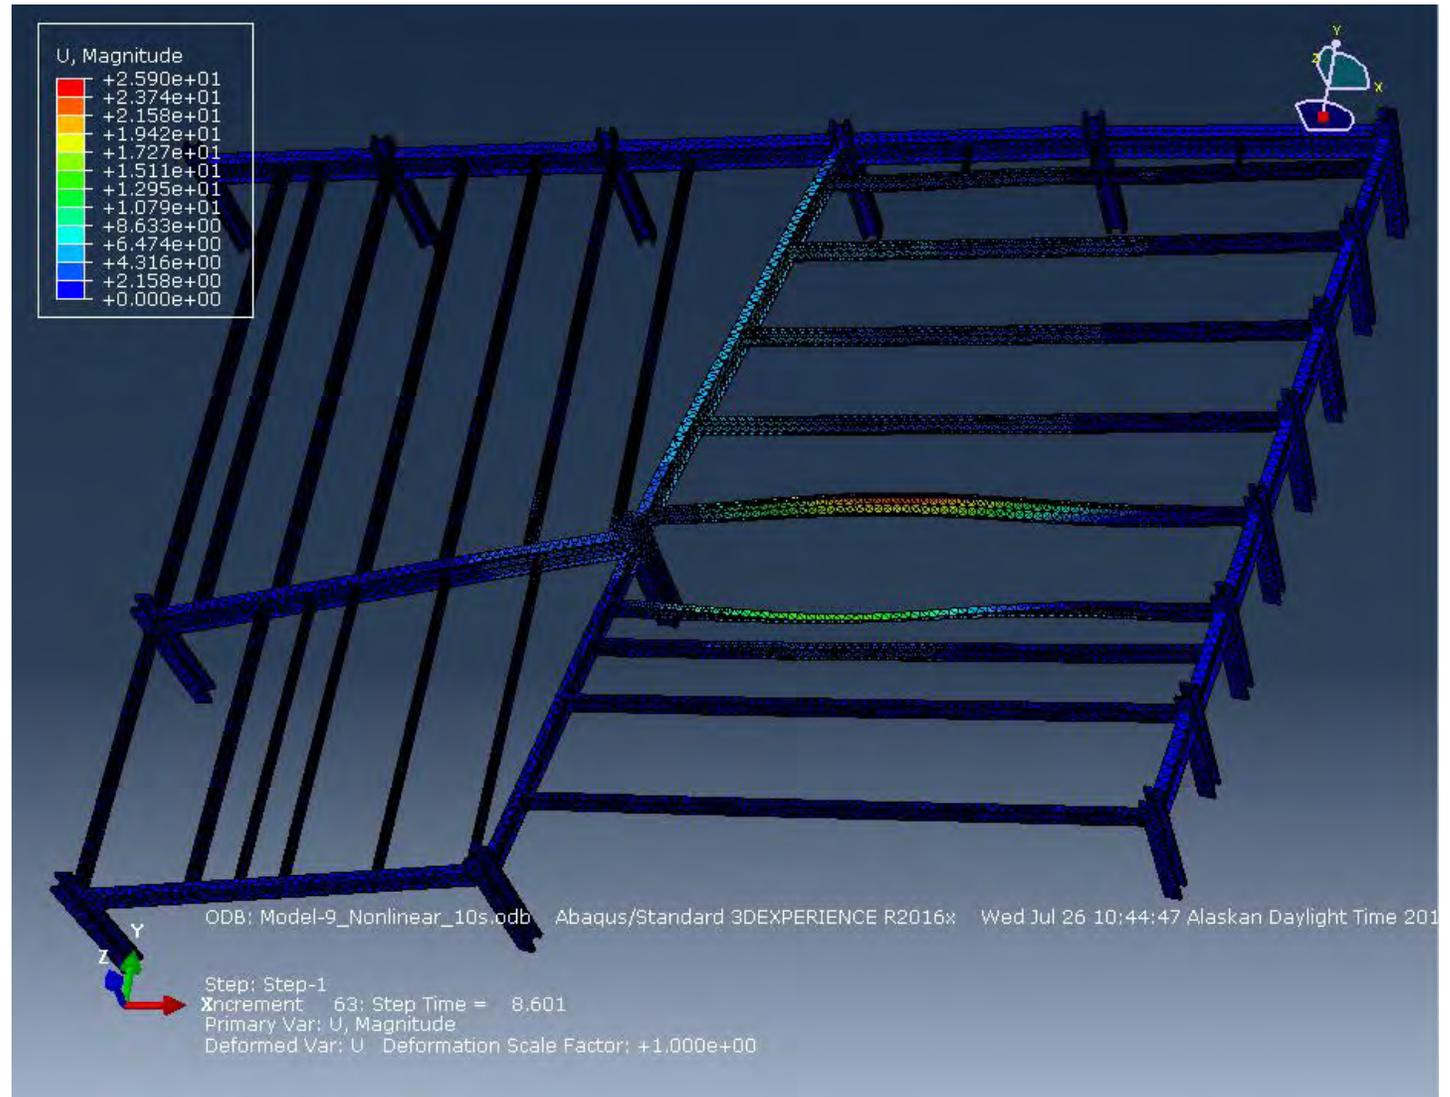
NIST WTC 7 Report Figure 8-22

This model shows the influence of the thermal expansion at the north east corner of floor 13.

When girder A2001 is trapped behind the side plate on column 79, beams K3004 and D3004 begin to buckle.

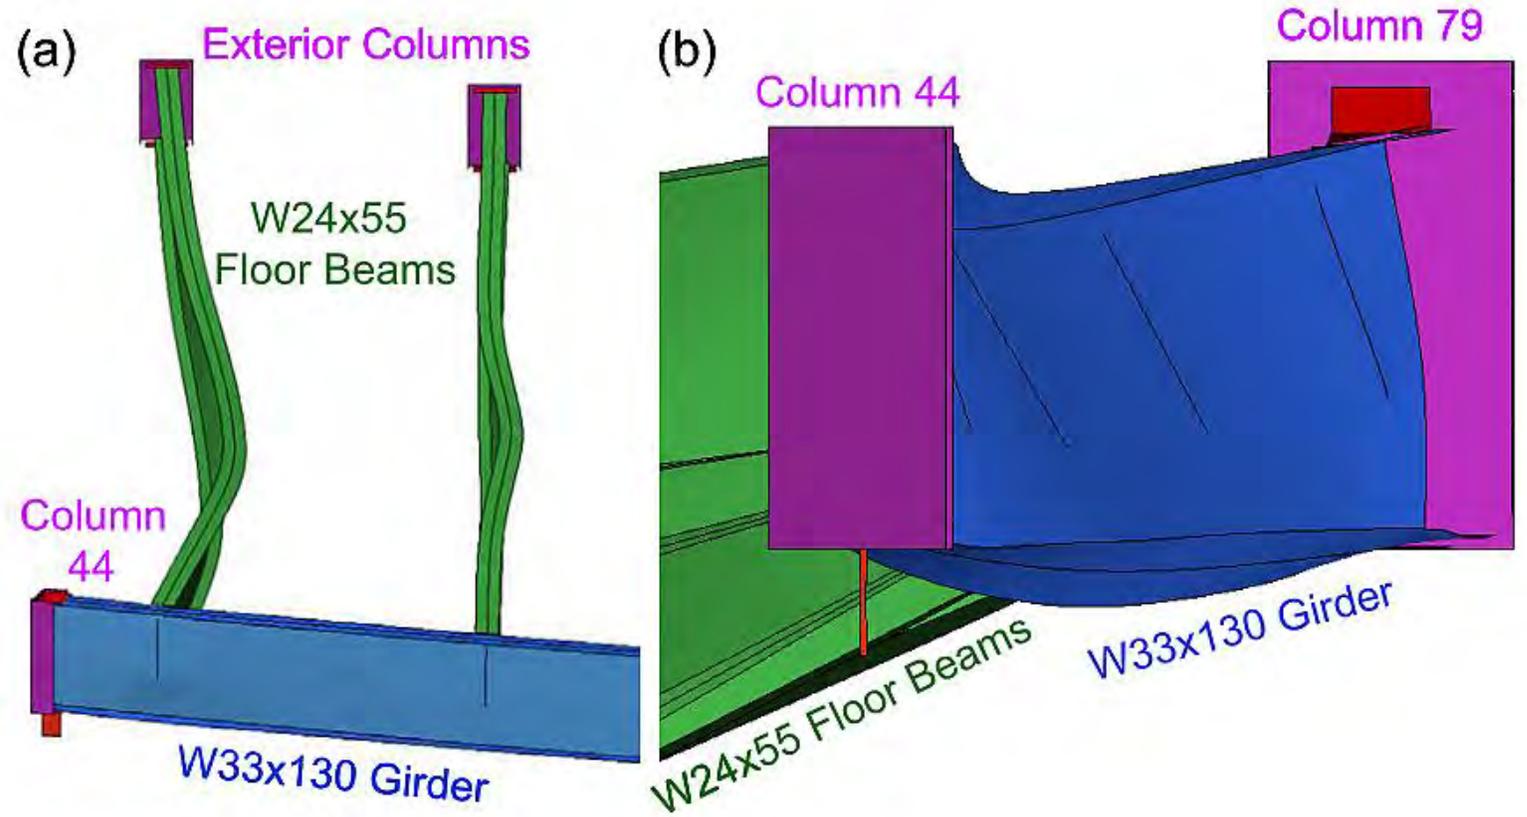
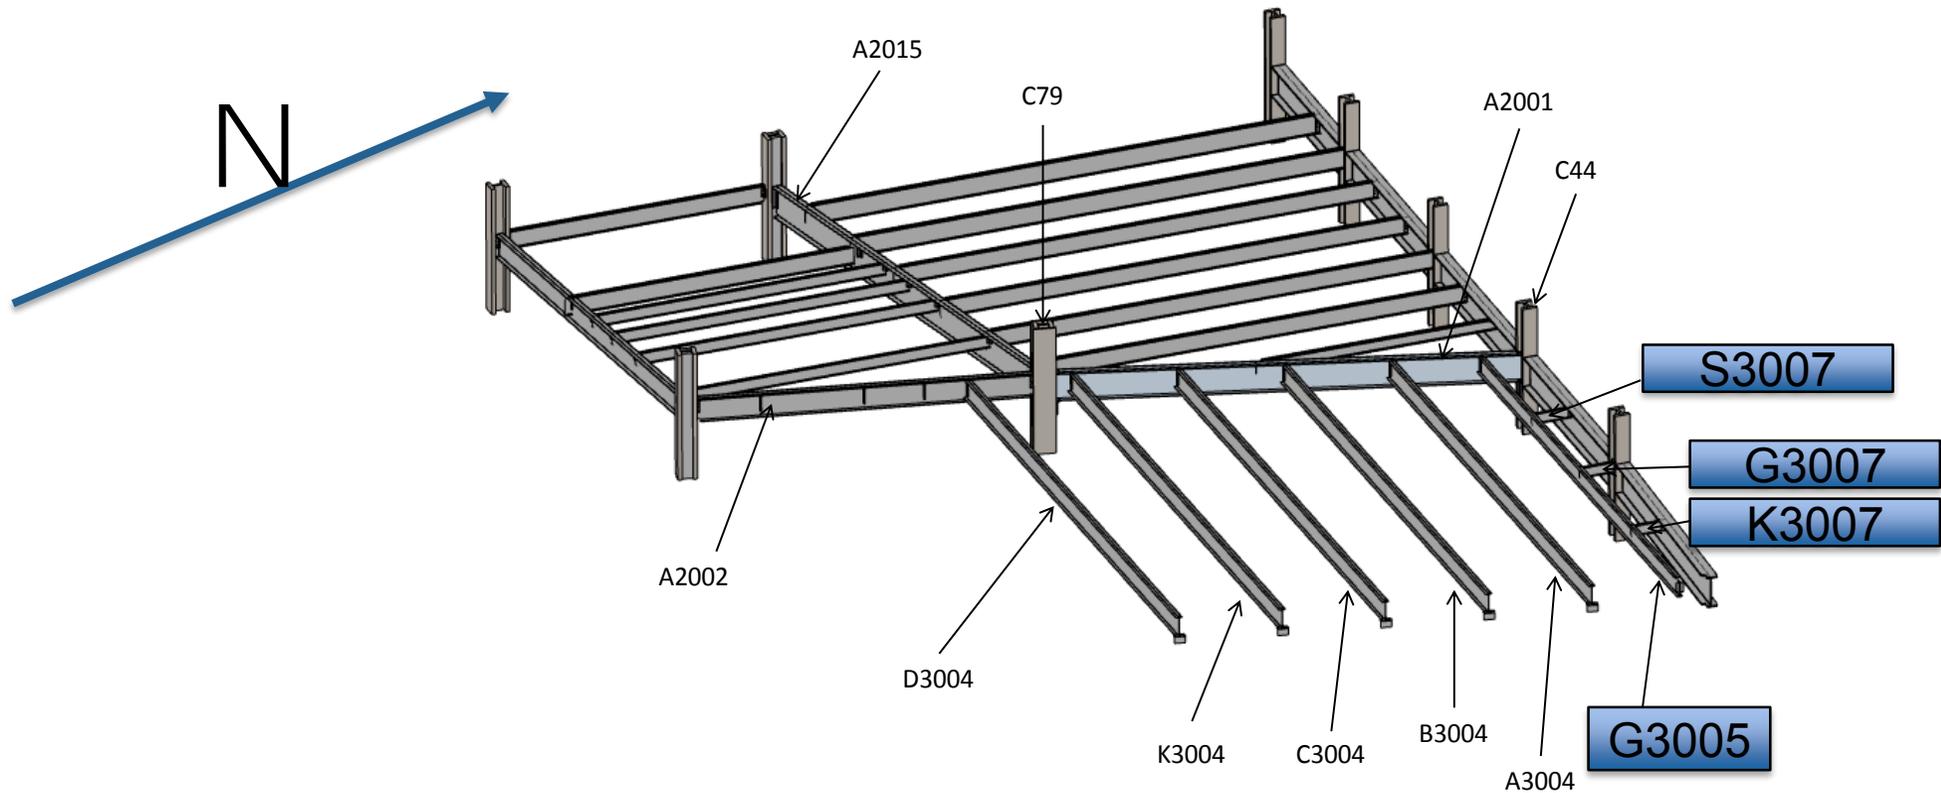
Lateral support beams S3007, G3007 & K3007 were left off G3005 in the NIST analysis.

UAF analysis showing beam G3005 does buckle when lateral support beams G3007, K3007, and S3007, spanning to it from the north exterior wall, are not installed.

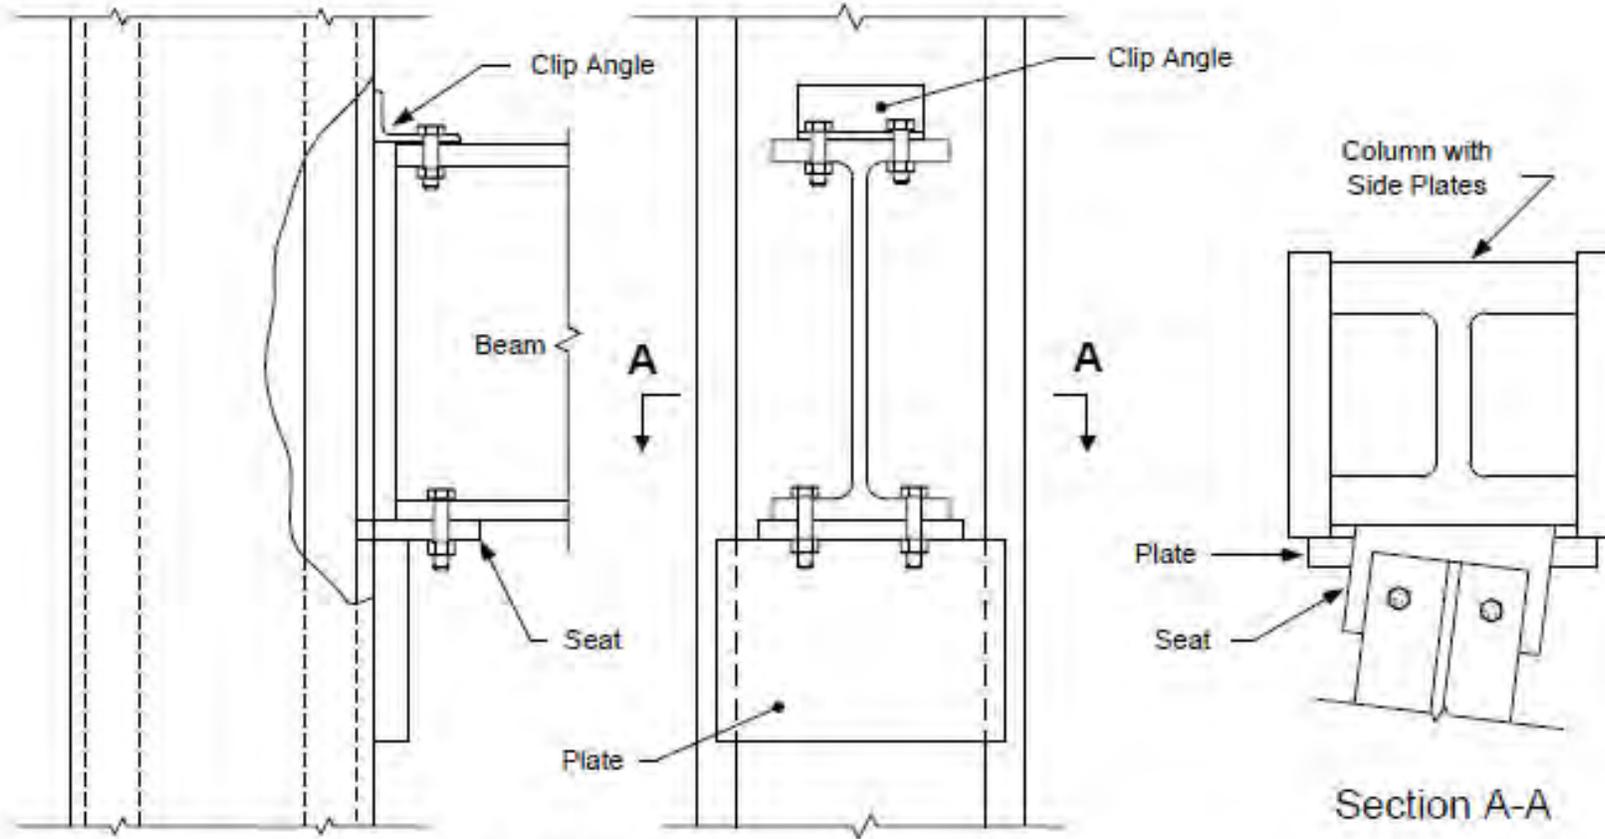
Figure 8-21. Seat connection at Column 79.

Note: partial height web stiffeners are missing; this is not per Frankel 1985.

The UAF analysis shows that the girder will not fail with the partial height web stiffeners installed. The small area of high stress is not in the load path and is due to the tip of the girder being compressed against the flange of column 79. This is not a structural concern.

Based on fabrication shop drawings (Frankel Steel 1985)

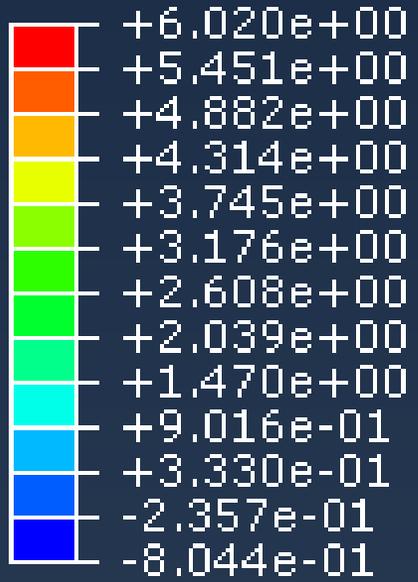
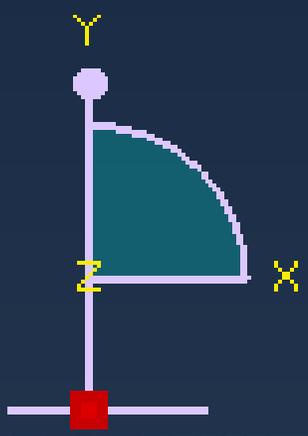
U, U1

Column 79 at Floor 13
(1.85 in, 0.94 in)

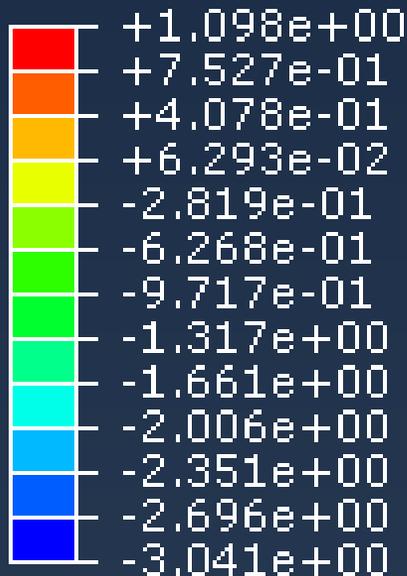
Vertical Movement

U, U3
