# Investigating the Mechanics of Destruction at the Twin Towers on 9/11: The Case for Propelled Demolition

By Wayne H. Coste, PE

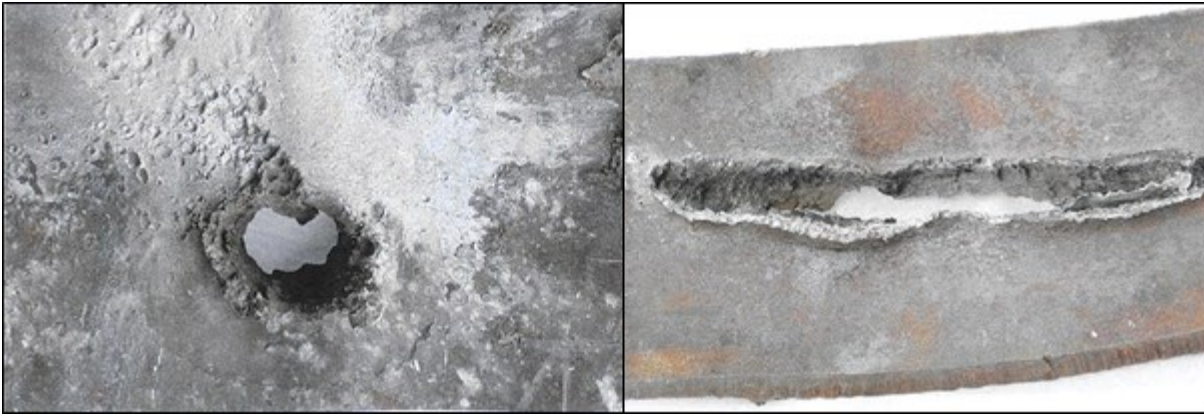
As shown in Figure 1, high explosives forceful enough to cut steel would leave behind an unmistakable forensic trail<sup>7</sup>. Damage from this mechanism was not documented in the remnants of the bent, ripped, torn and otherwise deformed steel.

**Figure 1: Holes punched through 1 inch steel plates from the explosive energy of shaped charges: Cone shaped charge (left); Linear shaped charge (right).**

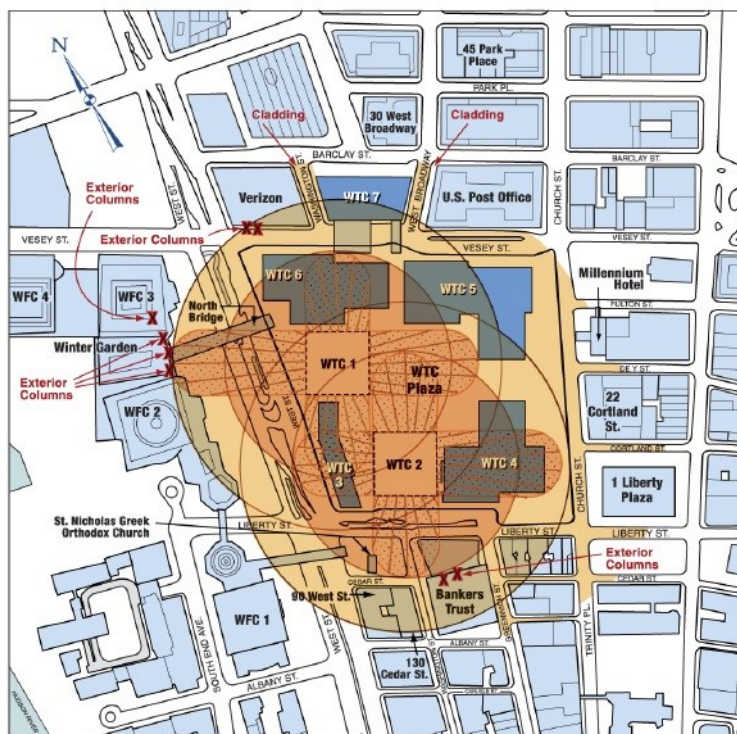
The 2002 FEMA report describes a 1,200 foot diameter debris field around each tower that is centered on the core as shown in Figure 2. As documented in this figure, each building is not only at the center of a circle of debris around each core, but each tower has significant documented ejection patterns in the cardinal directions (north-south-east and west). These north-south and east-west ejection patterns suggest forces emanating perpendicular to the core pushing the perimeter columns and floor structure outward in these directions. A corollary to this directionality is that that propelling forces were weakest in the ordinal directions (northwest, southwest, southeast and northeast). This directionality suggests the propelling forces did not act strongly into these corner quadrants of the towers. This suggests that the primary destructive forces emanated perpendicular to the core – and were not distributed uniformly throughout the floor-space.

Figure 1-7 Schematic depiction of areas of collapse debris impact, based on aerial photographs and documented damage. Striped areas indicate predominant locations of exterior steel columns. Inner circles indicate approximate radius of exterior steel columns and other heavy debris. Outer circles indicate approximate radius of aluminum cladding and other lighter debris. Heavy Xs show where exterior steel columns were found outside the predominate debris areas.

Figure 2: FEMA documentation of the epicenter of destruction of each tower and direction of ejected materials.

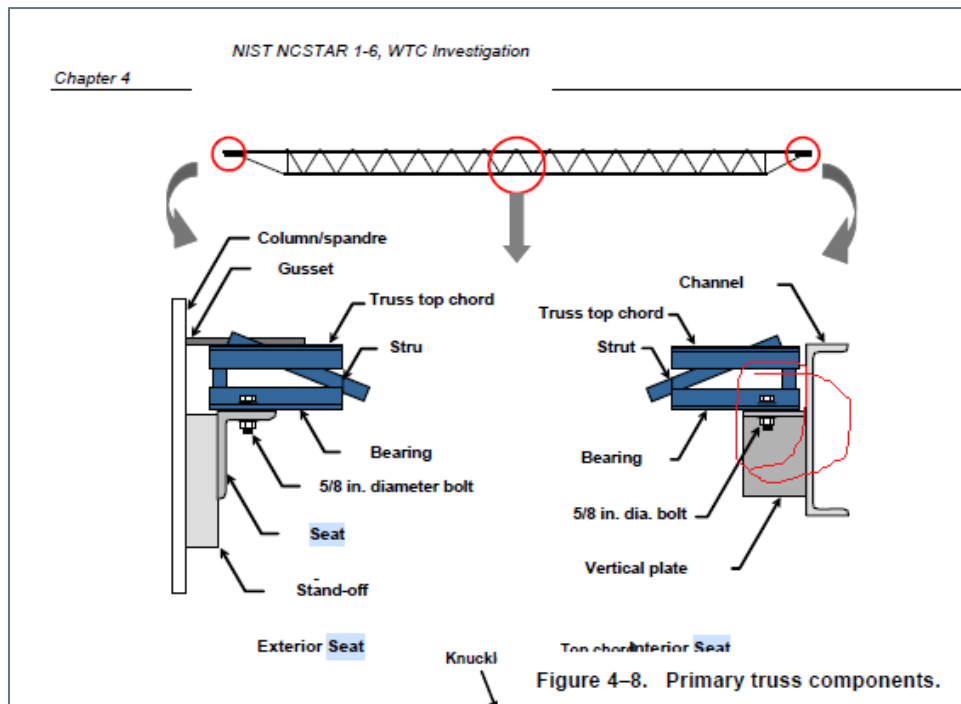
The connection of the floor trusses to the channel consisted of only two 5/8 inch bolts per truss. Figure 8 shows the floor truss connections between the perimeter columns on the left and the channel on the right (e.g., to the core column).

**Figure 8: Comparison of floor truss connections to core and perimeter columns. Note the gusset plate weld to reinforce the truss to perimeter column seat connection.**

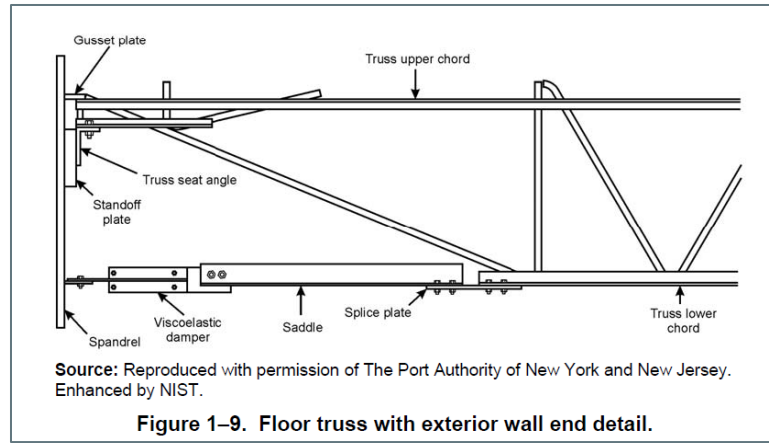
While the connection of the floor truss to the interior channel consisted of only two bolts, the connection to the outer perimeter columns was more structurally substantial. As shown in Figure 9, in addition to the two 5/8 inch bolts, there was a gusset plate that was welded between the perimeter column and the trusses' upper chord. Additionally, there was a viscoelastic damper that connected the trusses' lower chord to the perimeter column. Then, two additional connections per truss went to both the left and the right side at about a 45 degree angle to provide additional horizontal stability.

**Figure 9: Perimeter connection to floor truss showing viscoelastic damper.**

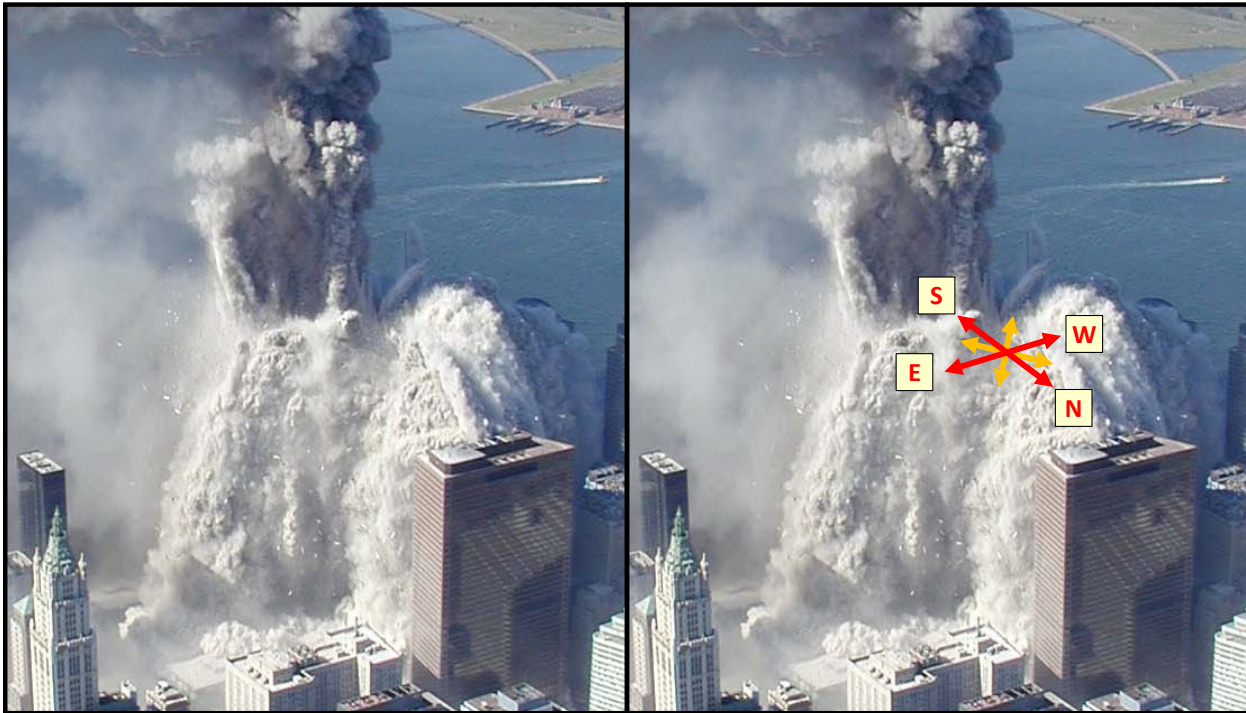
The directionality of the propulsive forces and "rooster-tail" hypothesized in this scenario match the observations captured in aerial photos of the destruction of the North Tower. It is unlikely that these "rooster tails" contained heavy steel components, but rather illustrate the movements of lighter materials. As shown in Figure 16, the propulsive forces operate in the cardinal directions of north-south and east-west (red arrows), which is consistent with the propellant being placed on the inside of the elevator shafts. As confirmed by the photograph, such a geometric arrangement would provide significantly less propulsive forces in the ordinal directions (orange arrows).

Figure 16: The majority of the propulsive forces in the cardinal directions creating "rooster tails" with significantly less propulsion in the ordinal directions. Photo by Detective Greg Semendinger/N.Y.P.D.

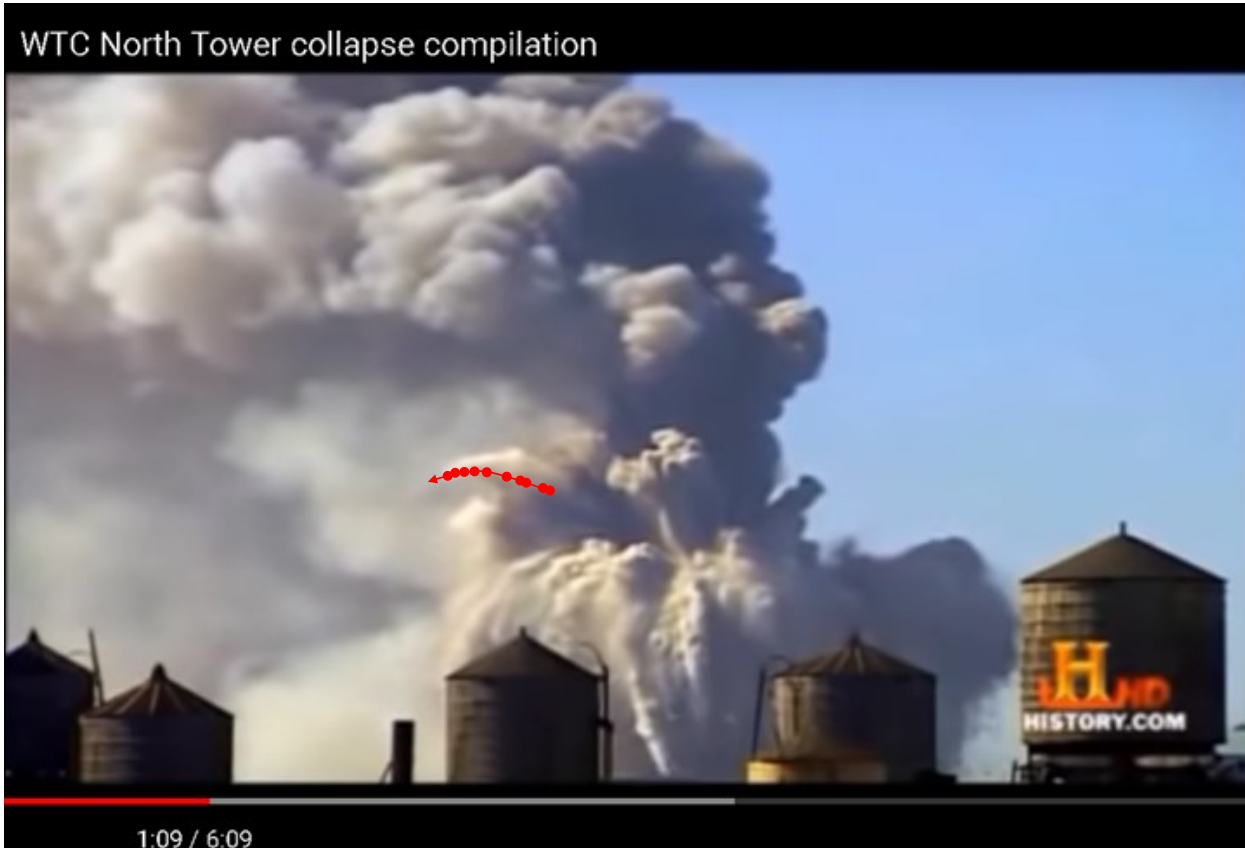
Figure 17 shows an upward-arching "Rooster Tail" that can only be explained by the reactionary force of the propellant and the geometry described above. Figure 18 shows the evolution of this "rooster-tail" by

**Figure 17: Upward-arching "Rooster Tail" can only be explained by the reactionary force of the nano-thermite based propulsive forces.**

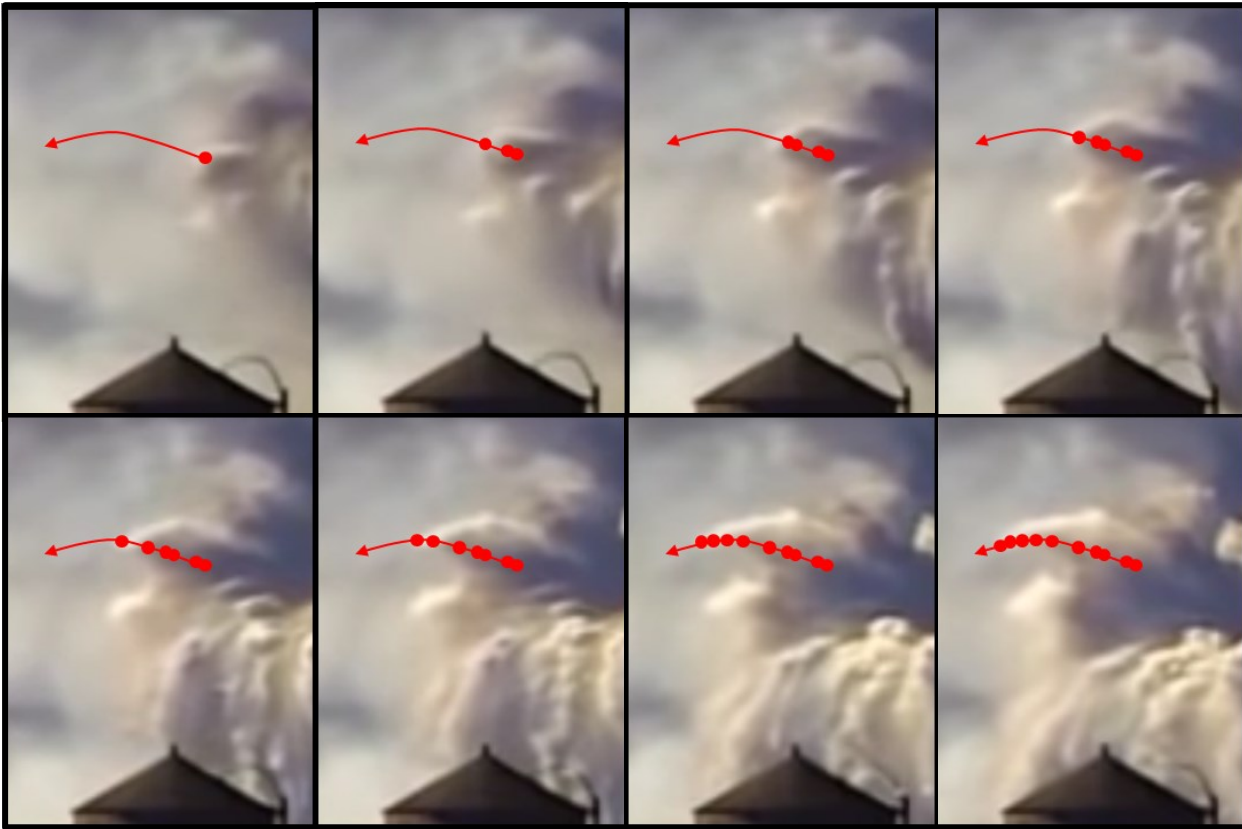
tracing the leading edge of a fast moving debris cloud with red dots as place markers. While the leading edge of this debris cloud is seen rising, peaking and then descending, it should be noted that the debris cloud trailing behind the leading edge can be seen rising further above the red trace. This confirms the upwardly directed reactionary propulsive force expected according to the hypothesis.

**Figure 18: Evolution of the upward-arching "Rooster Tail" with dots showing the leading edge of the entrained material. An upward billowing debris cloud can be seen above and behind the trace which further illustrates the reactionary propulsive force.**

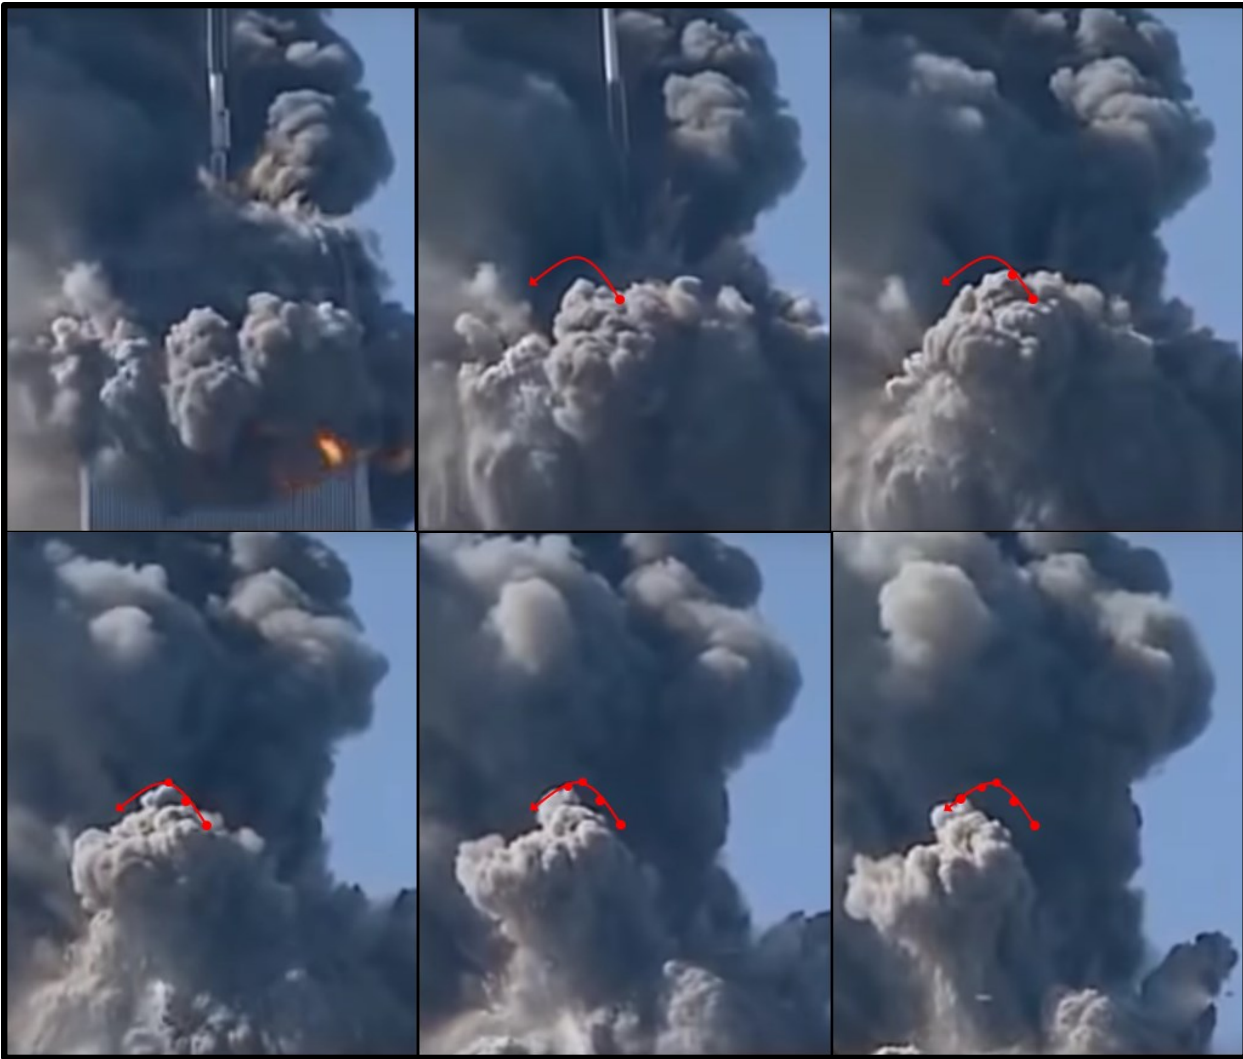
Another feature of the propellant that is observable because of the reactionary forces is the plume that erupts through the core area during the destruction phase. As multiple reactionary streams from the propellant collide in the core area, some portion will be forced upward. Figure 19 traces the upward movement of one section of this plume using red dots as place markers. The plume of debris is clearly rising against gravity and then it quickly begins to settle. If the plume were simply hot air containing micro particles it would continue rising, but instead it reverses direction and descends suggesting heavy macro-particulate loading.

Figure 19: Collision of opposing reactionary streams in the region of the core results in a vertically driven debris cloud plume.

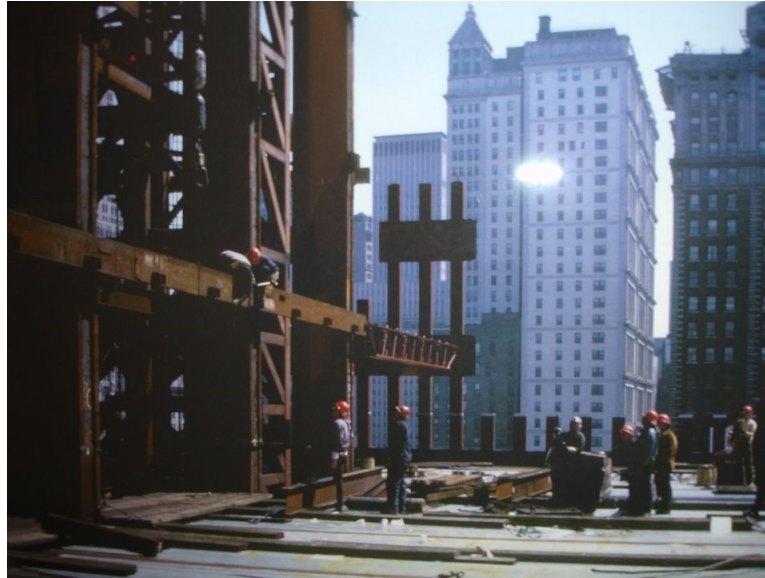
Figure 20 shows an installed steel channel that is solidly bolted to the core columns. The regularly spaced protrusions are the channel-to-floor truss seats described in Figure 8.

**Figure 20: Photo showing a channel with floor truss seats. A floor truss connecting the channel to a perimeter column is shown at the far end of the construction zone.**

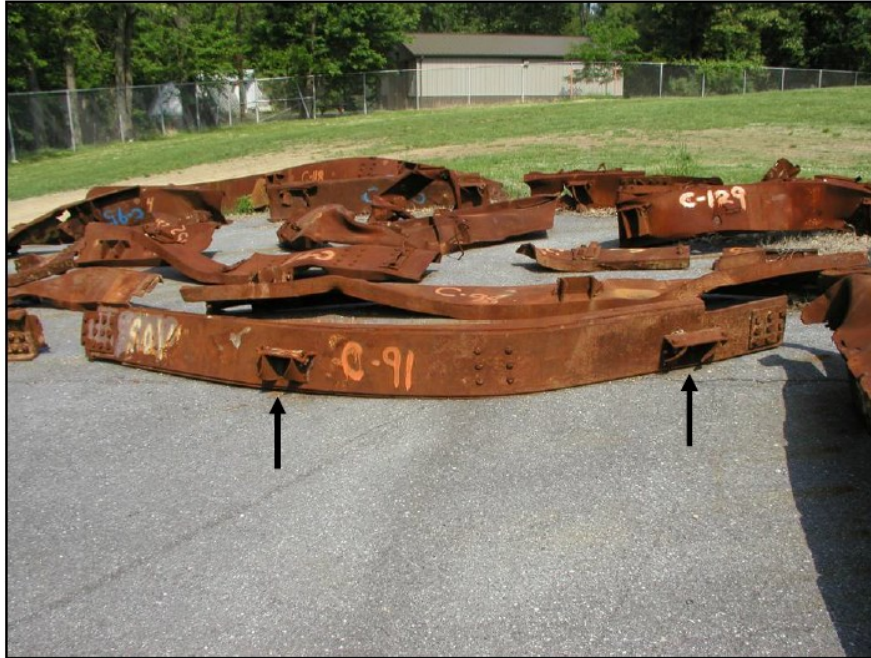
**Figure 4–6. Example of a recovered core channel. Arrows indicate seats used to attach the floor trusses to the channel (core columns).**

**Figure 21: Truss seats from “Zone1” and/or “Zone 2” do not exhibit the downward bending observed in “Zone 3.”**

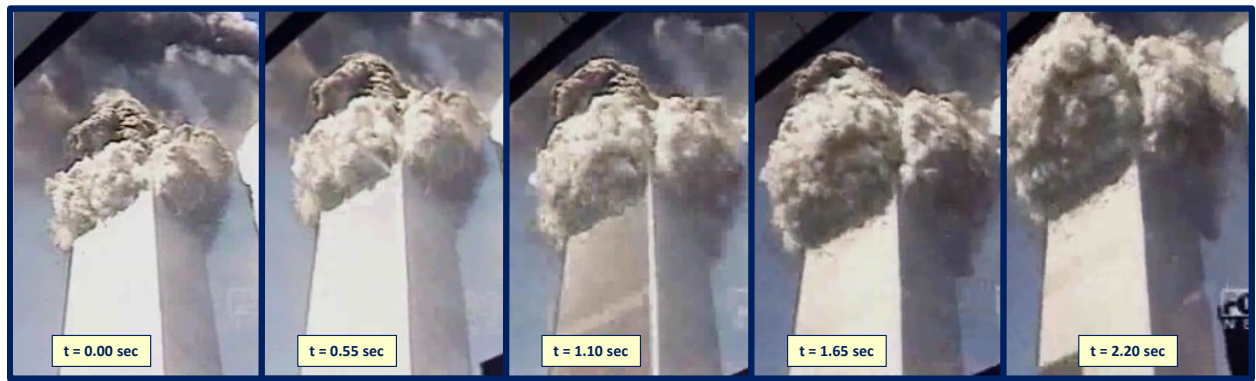
The sequential floor-by-floor destruction of the towers can be seen in Figure 27 for the South Tower and Figure 28 for the North Tower. In both cases the rate of descent is approximately constant and appears to be proceeding slightly faster than freefall acceleration during the Zone 2 demolition<sup>24</sup>. This observation about faster than freefall acceleration is because the ejected debris outside the tower from the higher floors (e.g., the debris is in free fall – including steel components) does not have time to fall and obscure the

Also, a review of the recorded sequence of demolition for each tower shows that the greatest propulsive forces occurred in the middle of each face of the tower. This supports the placement of the propellant along the inside perimeter of the elevator shafts. As expected for this hypothesis, the propellant is not observed acting with significant force into the corners (ordinal directions).

Figure 27: Using the debris cloud to observe the sequential activation of propellant - South Tower

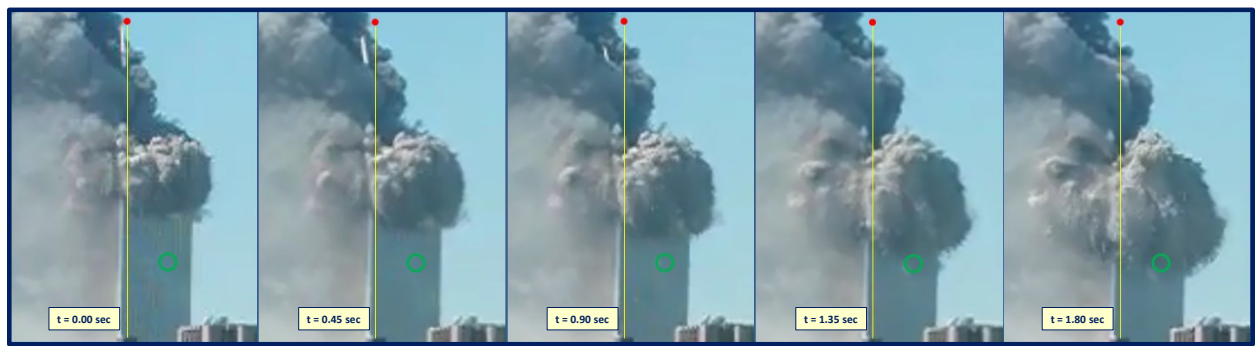
Figure 28: Using the debris cloud to observe the sequential activation of propellant - North Tower. Also note the antenna is both descending and falling to the left

While there is little evidence to determine exactly what happened at the interface between “Zone 1” and “Zone 2” there are some clues. As shown in Figure 28, the antenna on the North Tower does not rotate away, but rather it falls away as it is descending. This can be observed in the figure by comparing the top of the antenna to the red dot marking its initial location and then observing the motion in the subsequent frames. This is suggestive of the core columns on one side remaining intact slightly longer than the other and acting as a moment arm for the rotating upper block (i.e., the arm acts like a hinge).

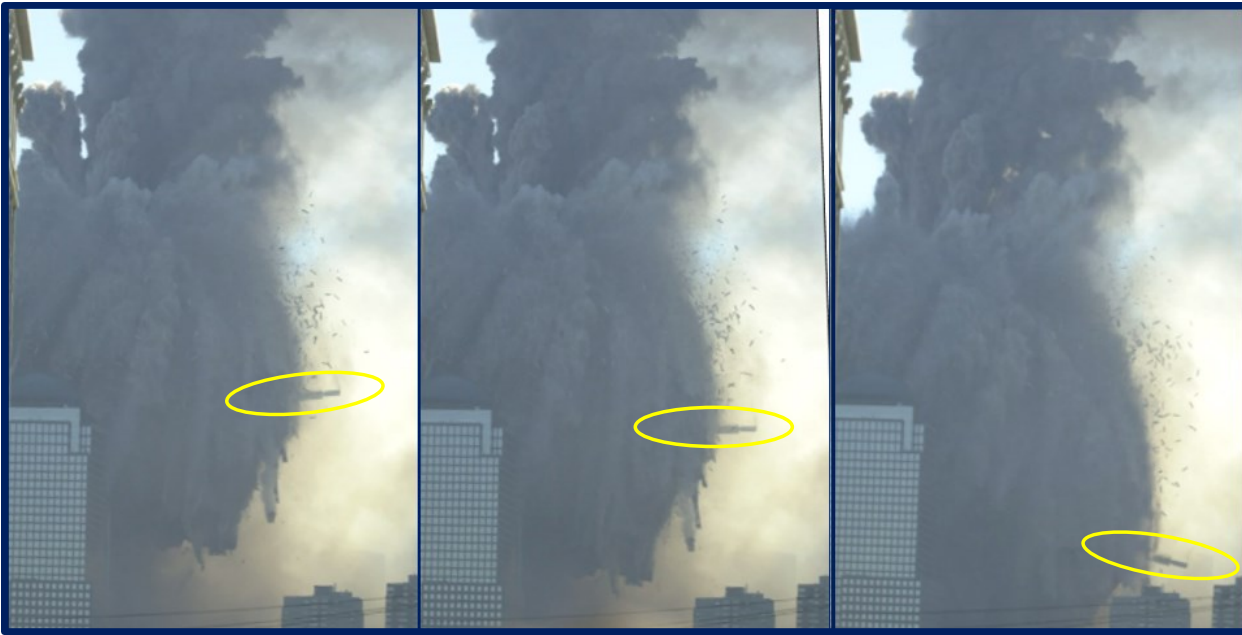
In Figure 28, the antenna is observed to both descend and rotate-away. Figure 29 shows the antenna of the North Tower falling to the side of the tower. These two figures show that the top 15 stories of the North Tower tilted as a single entity, similar to the top 30 stories of the South Tower, before each was propelled into oblivion. Because of its smaller height, the top of the North Tower was more easily obscured by the propelled debris cloud. Figure 30 shows the top of the both towers when the tilt of the top block first becomes noticeable.

**Figure 29: Tracing the descent of the North Tower antenna confirms the top 15 stories rotated as a single block and did not descend through the core of the tower (John O’Boyle /Star-Ledger).**

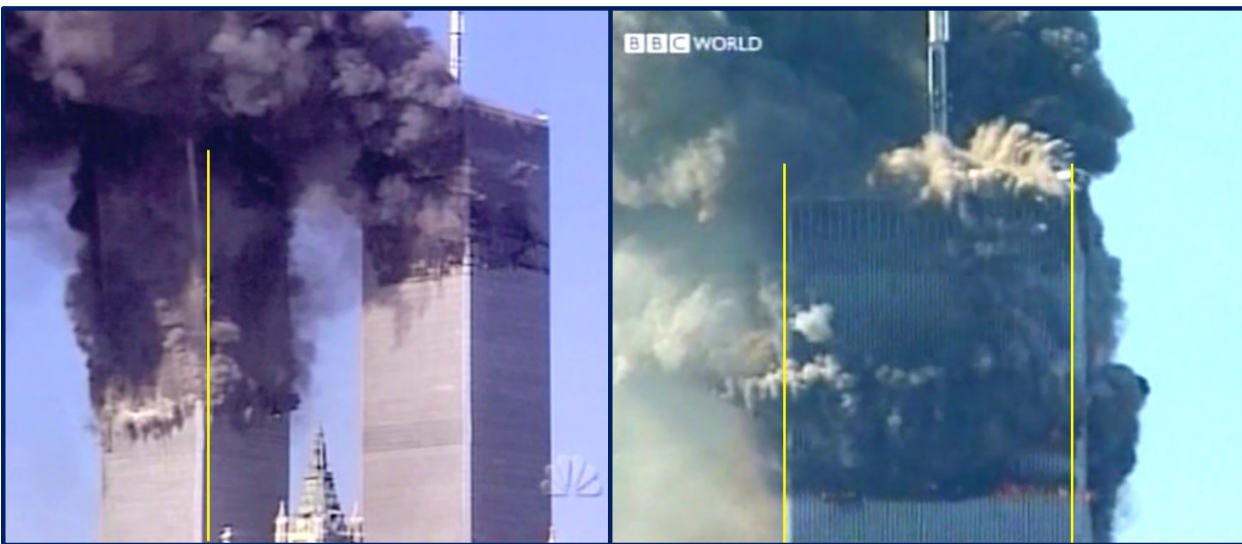
**Figure 30: South Tower starts to lean (left) and North Tower starts to lean (right)**

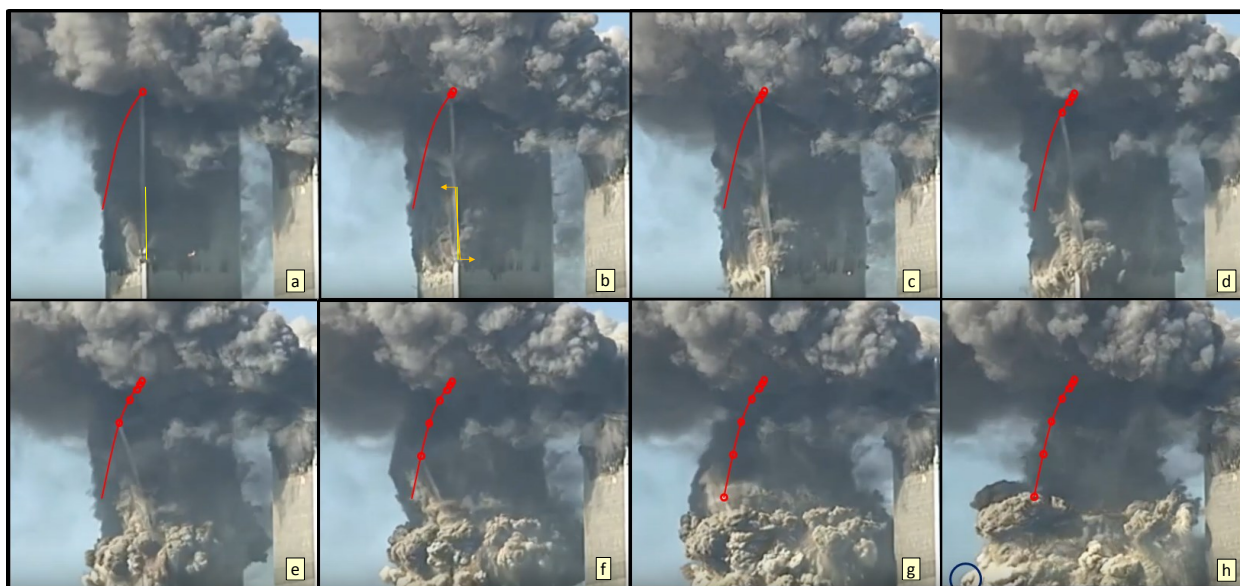
A similar movement is seen in the behavior of the South Tower<sup>25</sup>. Figure 31 highlights the movement of the northeast corner of the tower as it falls away and descends. The last frame in the sequence (frame “h”) shows the emergence of a row of the core columns through the debris cloud (e.g., the “blue” circle). The movement of these core column ends might provide clues about the location of the lower end of the moment arm. If it is assumed that the core columns were all weakened at the same elevation then the location of the initiation can be hypothesized. If this motion could be verified, it may suggest destruction of the columns a dozen floors below the location of the aircraft impact. The movement of these top blocks indicates that columns were not severed simultaneously as in WTC Building 7.

Frames “a” and “b” of Figure 31 show a yellow vertical line alongside the northeast corner where the buckling of the corner structure will be seen in frames “c” and “d.” In frame “c,” this corner region appears to bend outward for about ten floors in height above the interface. This suggests that the weight of the top block has exceeded the capability of the structure – and it is giving way to create the observed deformation.

The more interesting observation in these figures is the effect that is shown in frame “b” by the two orange arrows. The upper orange arrow shows the movement of the block in the outwards leaning direction, while the lower orange arrow shows the inward movement due to the hinge effect – as the top block begins to tilt. This is the source of the “inward bowing” movement observed at the onset of destruction of the South Tower.

**Figure 31: Rotational sequence of the South Tower showing the position of the northeast top corner during descent. Frame (h) shows the emergence of a row of core column.**

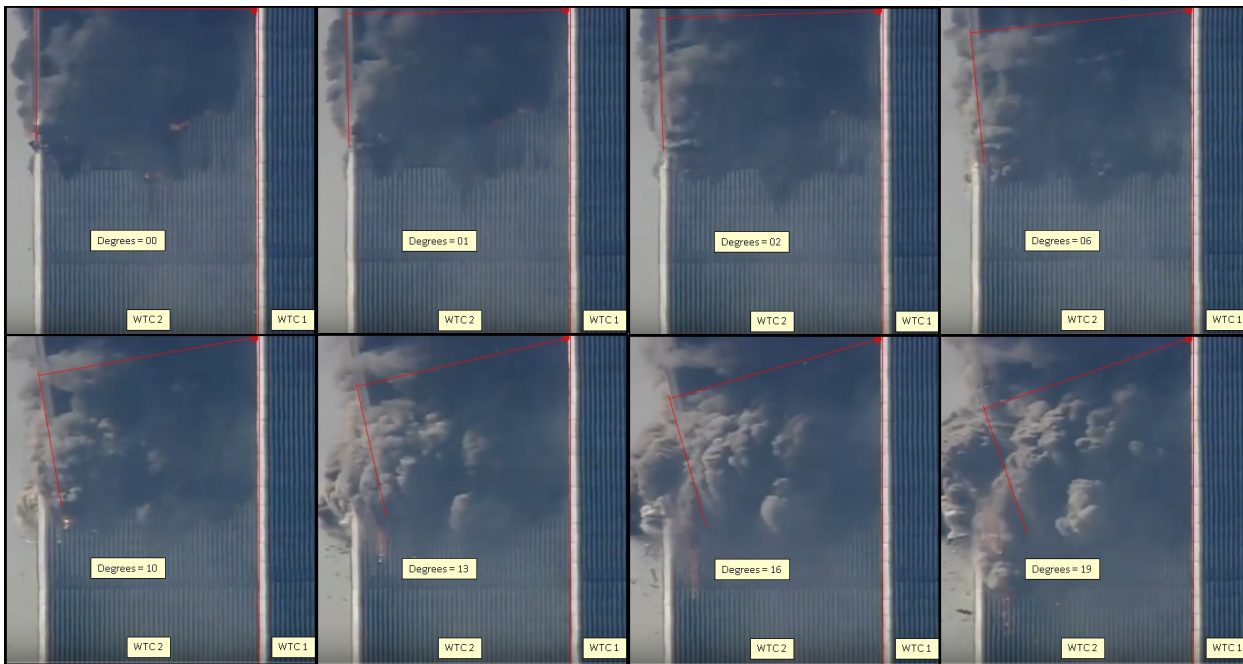
By tracing the movement of the edge of the South Tower, Figure 32 shows the hinging action that provides the inward forces indicated by the lower orange arrow in frame “b” of Figure 31.

**Figure 32: Rotation of the top block of the South Tower suggests a pivot point approximately marked at the circle.**

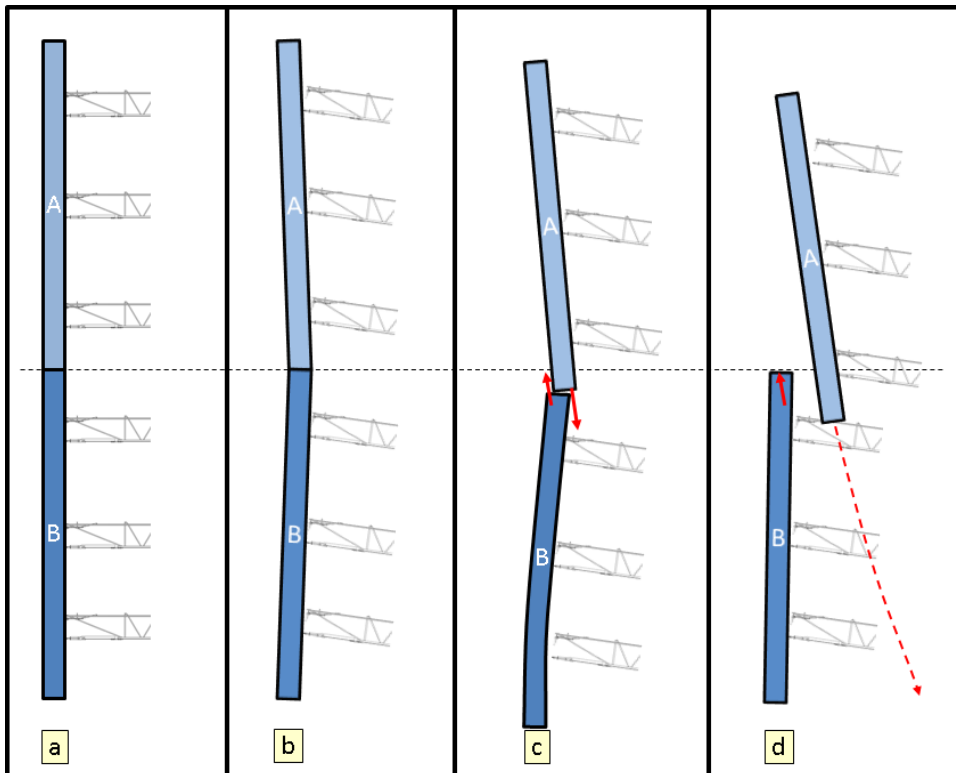
Figure 35 shows a conceptual explanation for the perimeter column rebound. In frame “a,” the columns are aligned vertically with their normal loadings immediately after the plane impact. Frame “b” shows the effect on some of the sagging core columns that resulted in perimeter column pull-in. The greatest amount of pull-in is where the perimeter columns were weakest (e.g., the floor where the plane passed into-and-out-of the Tower destroying some perimeter columns). Frame “c” shows the effect of the destruction of additional core columns where the additional load on the perimeter columns exceeds the yield strength of the perimeter column steel (e.g., yield strength means the steel is compressible by some amount). Here the lower perimeter column is compressed below the dotted line. With the increasing angle between butt-ends, the bolted connections begin snapping. Frame “d” shows the separation of the bolted connection and the rebound of the lower perimeter column. The upper perimeter column continues downward along a curved trajectory determined by the hypothesized moment arm and hinging effect once the rotation of the top block is no longer impeded.

**Figure 35: Conceptual explanation of perimeter column rebound: (a) post impact; (b) with core column sag; (c) additional weight squashes steel; (d) rebound begins after bolts break and rotation of top block is not impeded.**

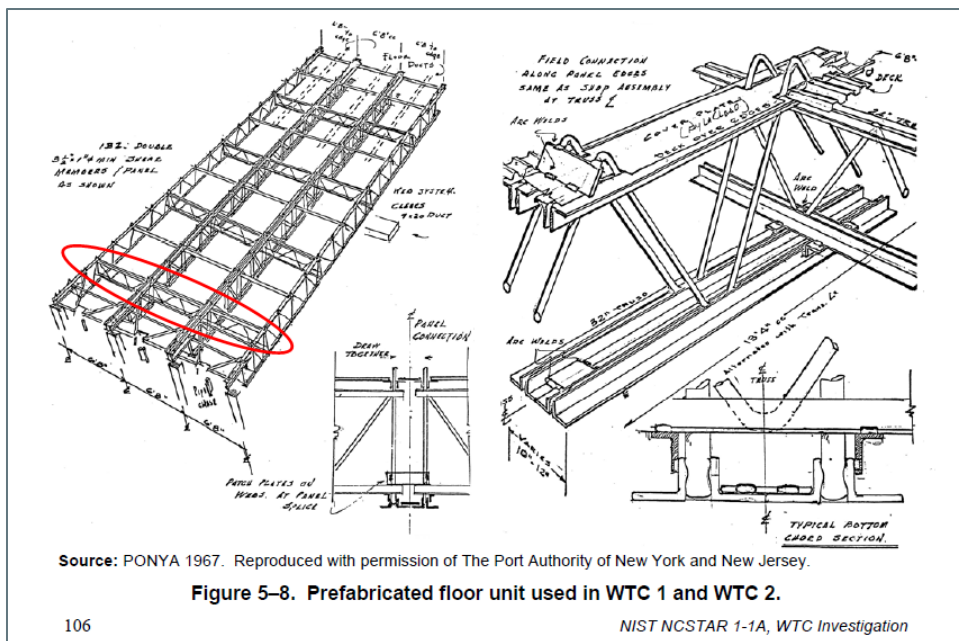
Figure 37 shows a prefabricated floor truss assembly. On the left, one of the cross-bracing structures is highlighted by a red oval. These cross-braces would have provided a small, but significant, cross-section for the propellant to impact as it traversed across the office area. The forces pushing the cross-bracing structures toward the perimeter columns would have the ability to not only dislodge the floor trusses from the concrete slab, but also yank them out and pull them along – thus fragmenting the concrete floor slab.

**Figure 37: Floor truss assembly showing cross-bracing (red oval) that would have provided a significant cross-section for the propellant to impact as it traversed across the office area.**

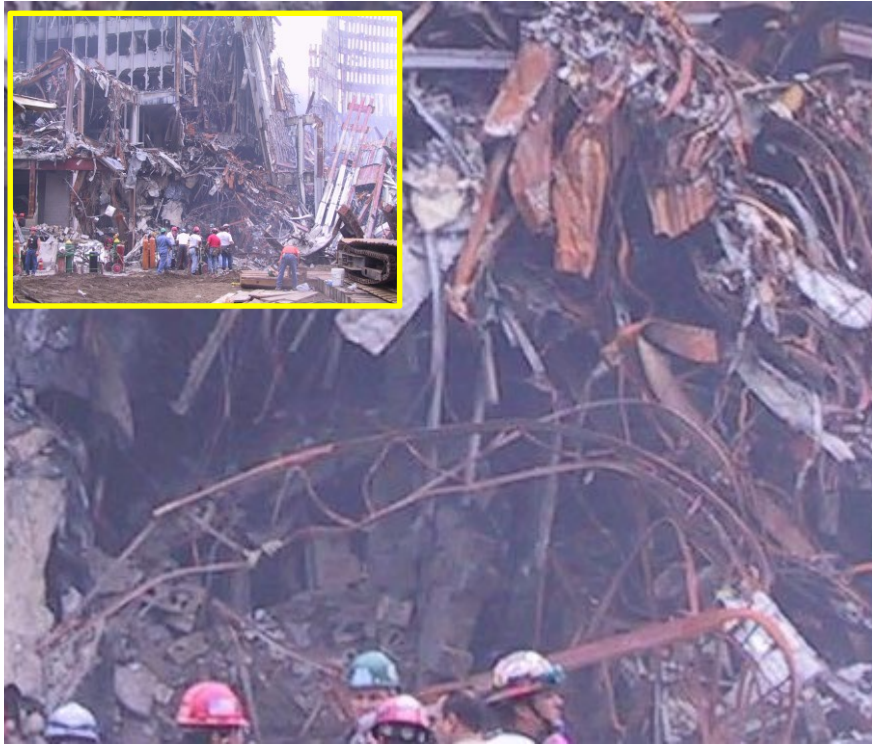
In reviewing photos of the debris across all the devastation, only one assembly, shown in Figure 39, is identifiable as a floor truss. Such deformation of these floor truss assemblies into their unrecognizable

component pieces is supportive of the effects of a high speed, energetic propellant traversing from the core toward the perimeter columns and exerting forces on any object in its path.

**Figure 39: The only identifiable floor truss observed in photographs of the WTC debris field**

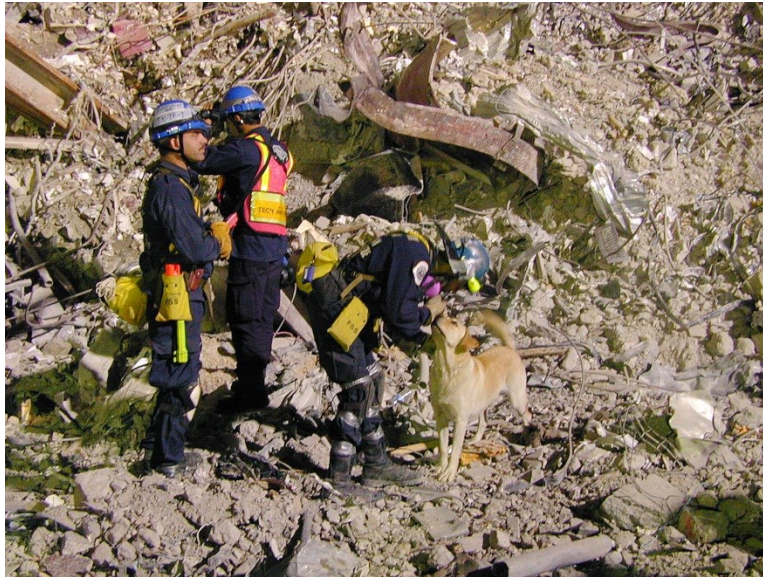
A great deal of broken concrete was photographed in the debris around the Twin Towers. Many of the pieces captured in the photographs are small. Figure 40 and Figure 41 show significant amounts of broken concrete in the debris pile.

**Figure 40: Showing Concrete chunks at the WTC. Source: FEMA\_-\_3945\_-\_Photograph\_by\_Michael\_Rieger\_taken\_on\_09-18-2001\_in\_New\_York**

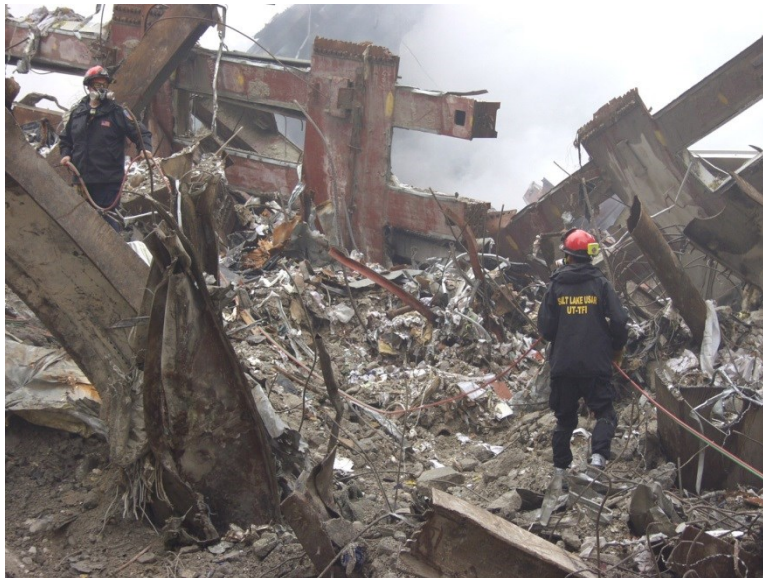
**Figure 41: New York, NY, September 20, 2001 -- Rescue workers from the Utah Task Force-1 Urban Search and Rescue team prepare debris to be cleared at the World Trade Center crash site. Photo by Mike Rieger/ FEMA News Photo**

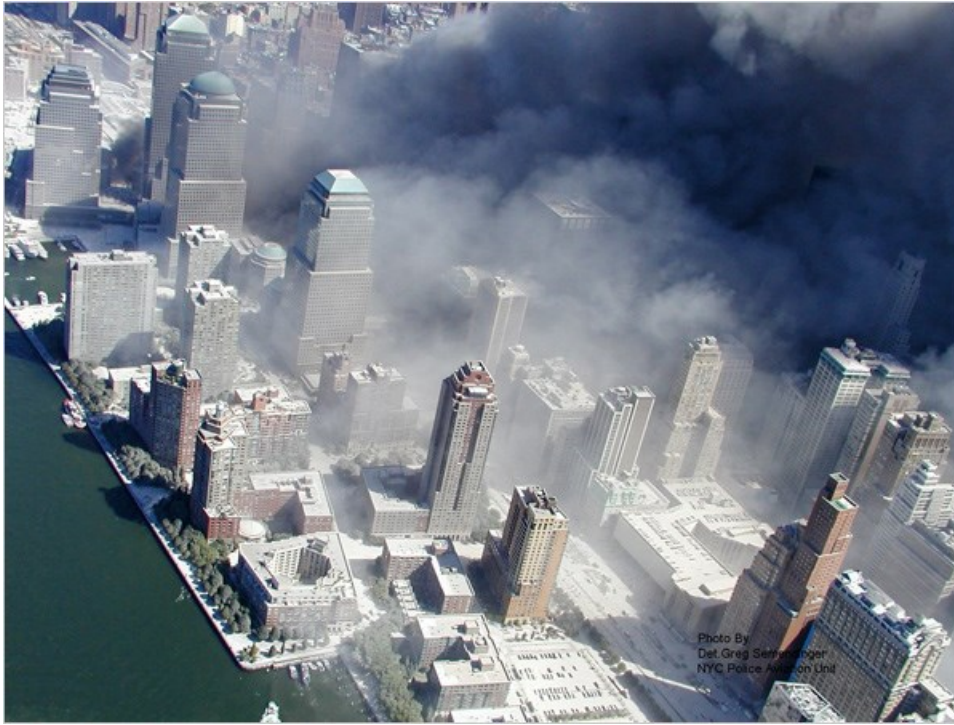
Figure 43 shows an aerial view of the dust deposits on the Manhattan landscape after the collapse of the North Tower, as well as the fine dust still entrained in the air. Chunks of concrete, and even large particles, would settle out near the WTC complex and would not travel from river-to-river.

**Figure 43: A fine white dust covers much of lower Manhattan. Photo by Detective Greg Semendinger/N.Y.P.D.**

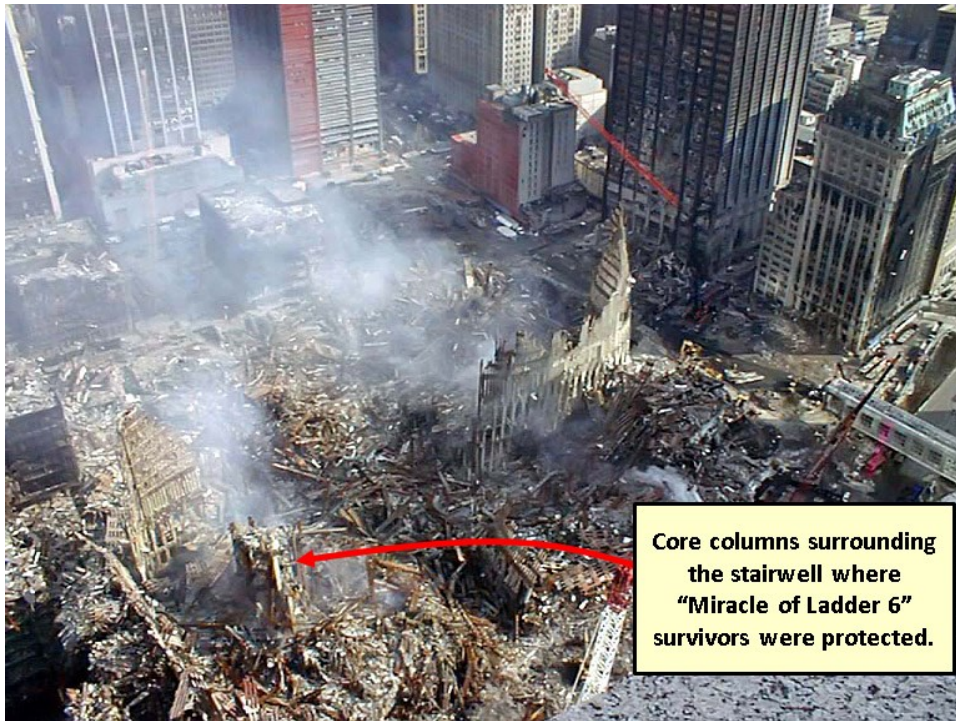
The demolition of “Zone 3,” which consists of the 50 foot high atrium and basements, was very different from the demolition of “Zone 1” and “Zone 2.” It appears that this happened because there were no floors in Zone 3 that needed to be propelled outward. The evidence shows that this area was crushed by falling debris and was not subjected to a propellant-based demolition. Figure 44 shows the area where 13 survivors<sup>36</sup> of the destruction of the North Tower were safely ensconced during the demolition. The north and west perimeter columns are shown standing with about four floors of core columns visible in the center of the devastation. Figure 45 shows a close-up of the survivor’s stairwell during the debris removal phase of the clean-up.

Figure 44: Post demolition view of "Zone 3" with the North Tower (left) and South Tower (right) with the core columns protecting the survivors in the 4<sup>th</sup> floor stairwell identified by the red arrow.

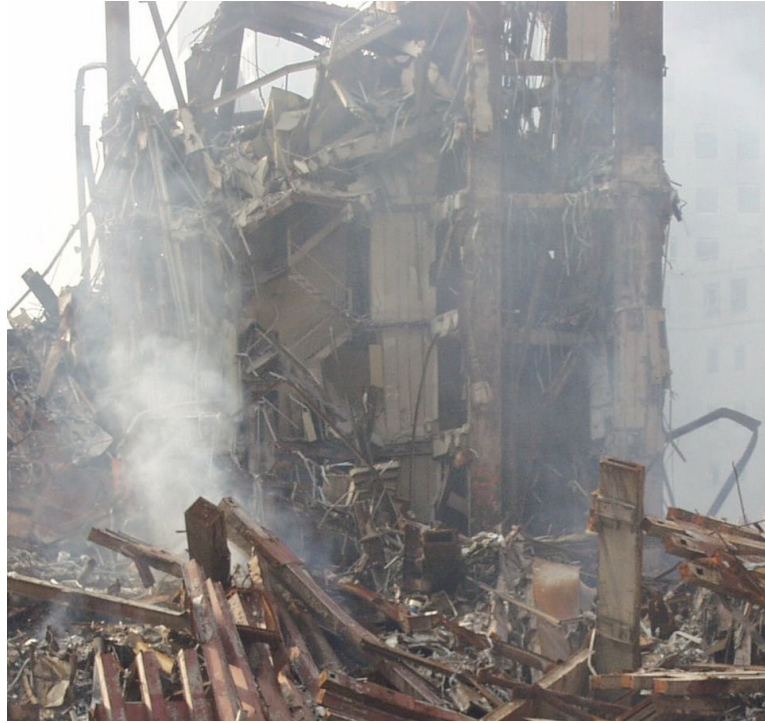
**Figure 45: Close-up of the survivor's stairwell during debris removal. The stairs can be seen along the inner wall of the elevator shaft / core area.**

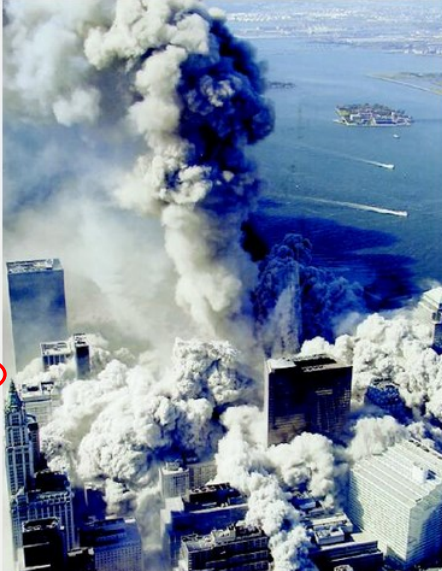
To provide support for the reasonableness of the propelled-demolition hypothesis, an estimate of the quantity of activated propellant observed during the demolition is useful. As shown in Figure 48, Jim Hoffman provided an estimate of the energy released based on the expansion of the dust cloud. He estimated that the energy released during the destruction of the North Tower would have been in the neighborhood of 1,500,000 kWh of energy (1.5e6 kWh or 5.4e12 Joules). The data shown on Figure 49 allows the energy density of nano-thermite (abbreviated as “NT” for these calculations) to be calculated. From the graph, the energy per gram is estimated to be 3,000 Joules/gram-NT. Along with the assumption that an “oxygen balanced iron thermite” would have the density<sup>38</sup> of 4.175 g/cm<sup>3</sup> yields 12,525 Joules/cm<sup>3</sup>-NT. With these assumptions, an estimated total 3.81e8 cm<sup>3</sup>-NT would need to be activated to produce the estimated 1.5e6 kWh of energy.

- Dust cloud of North Tower expanded to about 5 times building volume by 30 seconds from collapse start.
- Heat energy is required to produce expansion:  
Ideal gas law:  $PV = nRT$  where:  
 $P$  = pressure  
 $V$  = volume  
 $T$  = absolute temperature
- Heat required over 10X gravitational potential energy
  - Energy required for 3.4X expansion is on the order of 1,500,000 kWh.
  - Gravitational energy was about 100,000 kWh.

**Figure 48:** According to Jim Hoffman, energy released during the demolition can be estimated by the thermal expansion of the dust cloud.

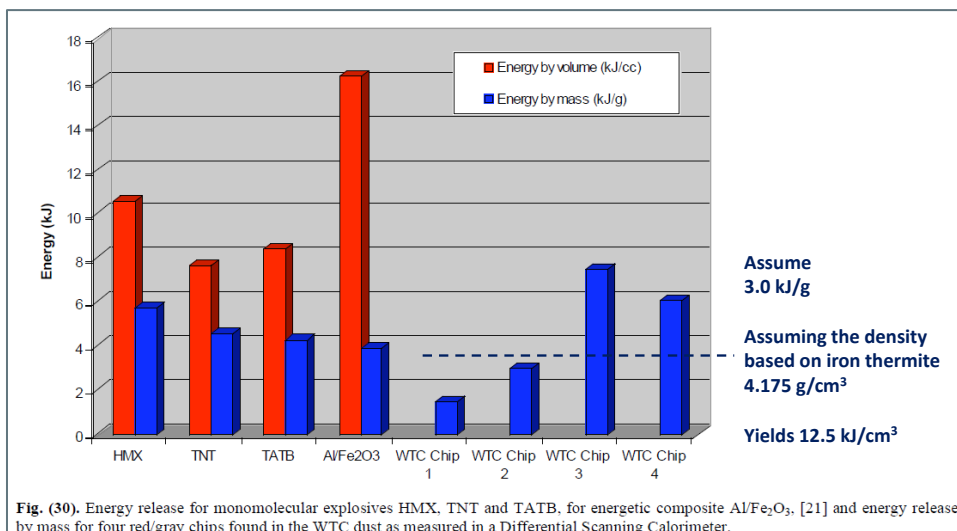
**Figure 49:** Annotated Figure 30 from Harrit et al showing basis for energy density

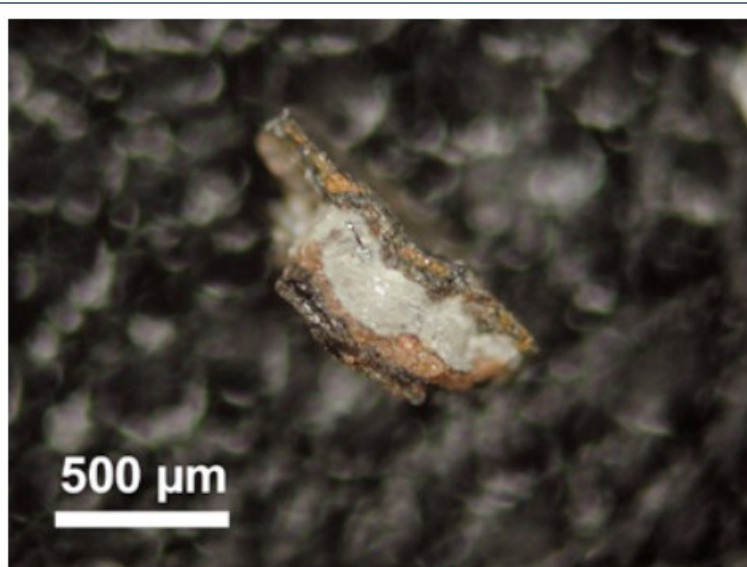
The estimated thickness of 0.755 cm is approximately 40 times larger than the 200 micron thickness of the red plus gray layers of the individual chips analyzed in the Harrit et al paper. A single 200 micron thick spray-on layer of the hypothesized NT-propellant would only provide 40,000 kWh of energy. This seems far too low and represents only 40 percent of the potential energy of each tower (e.g., effect of gravity, mass and height). This suggests that to produce the estimated 1.5e6 kWh of energy, the applied nano-thermite based propellant would need to consist of nearly 40 layers of the red-gray nano-thermite. This would likely necessitate installing pre-fabricated panels instead of spraying on 40 coats of alternating red-then-gray layers (if alternating layers of red and gray material are needed). Figure 50 shows an example of a multi-layered red-gray chip.

**Fig. (31).** Photomicrograph of a red/gray chip found in sample 3, showing multiple layers and an unusual light-gray layer between the red layers.

**Figure 50: Example of multiple layers.**
