# Investigating the Mechanics of Destruction at the Twin Towers on 9/11: The Case for Propelled Demolition

By Wayne H. Coste, PE

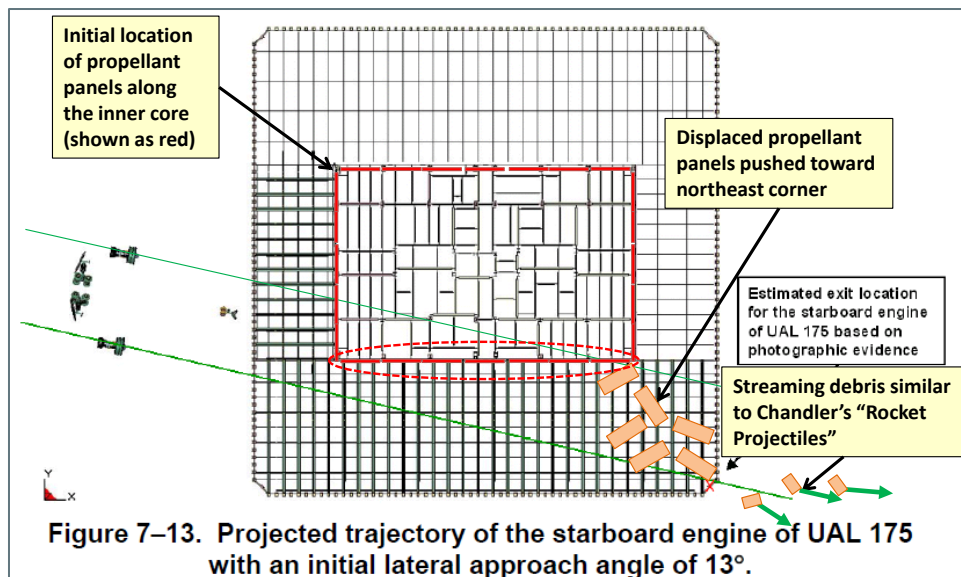
The presence of multi-layered propellant panels around the core (e.g. 0.755cm thick) provides a theoretical basis for the occurrence of some previously unexplainable observations. As illustrated in Figure 51, the impact of UA175 into and through the South Tower would have knocked down some of the hypothesized propellant panels across several floors. This illustration shows, conceptually, a number of panels knocked toward the northeast corner of the South Tower with some fragments propelled out of the building in a northeasterly direction.

**Figure 51: Displacement of propellant panels in South Tower upon impact may explain glowing debris and molten iron pouring from the building at this location.**

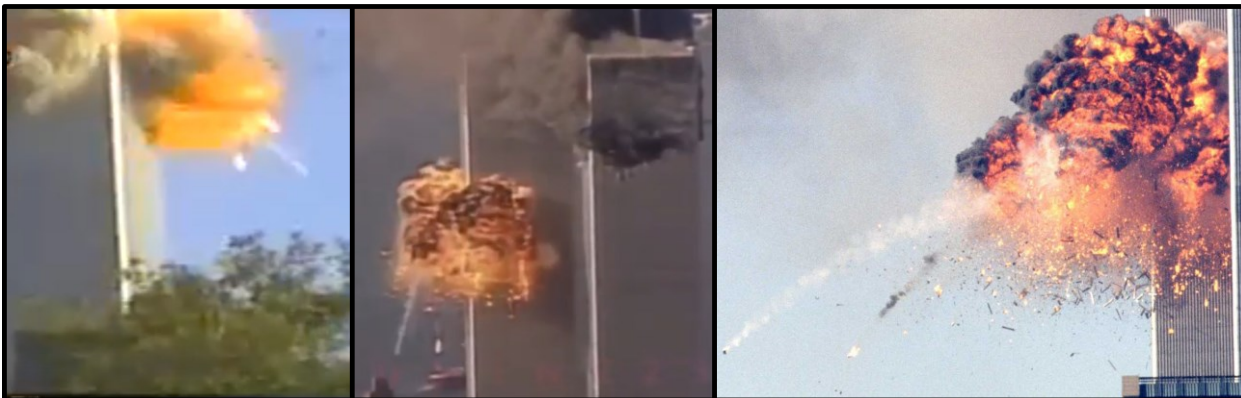
Figure 52 shows three images– concurrent with UA175 impact – in which activated, propellant-driven objects are seen moving away from the tower at a very high rate of speed – while trailing white smoke. These projectiles are very similar in character to the “rocket projectiles” shown in Figure 53, which David Chandler discussed<sup>40</sup>. It appears that some portion of the propellant was easily ignited during the energetic collision of the plane into the building structure<sup>41</sup>. It is quite possible that other projectiles may have been activated and flew in other directions, but were contained within the tower structure.

**Figure 52: Three views of post-UA-175 projectiles at the South Tower exhibit trailing white smoke that is very similar to the "rocket projectiles" described by David Chandler.**

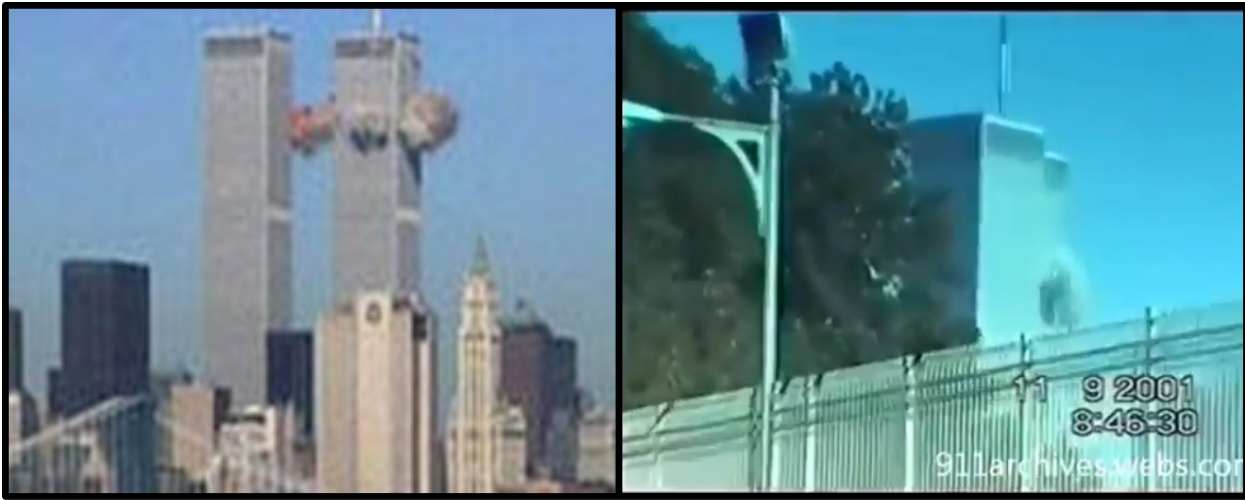
Figure 54 shows two views of the propellant activation as AA 11 impacted the North Tower. The mushroom activation pattern in the east face is similar to the activation pattern that was observed during the demolition phase of both the North and South Towers, whereby the propellant force was directed outward – perpendicular to the core region and not seen in the corners. Figure 55 shows the propellant activation across several floors from a side view as captured by the Naudet brothers.

**Figure 54: Photograph of the North Tower impact by Wolfgang Stahle (left) that shows ejections from the east face of the North Tower which has the same characteristics as seen during the propelled demolition of the Towers. Another view captures the ejection from the east face.**

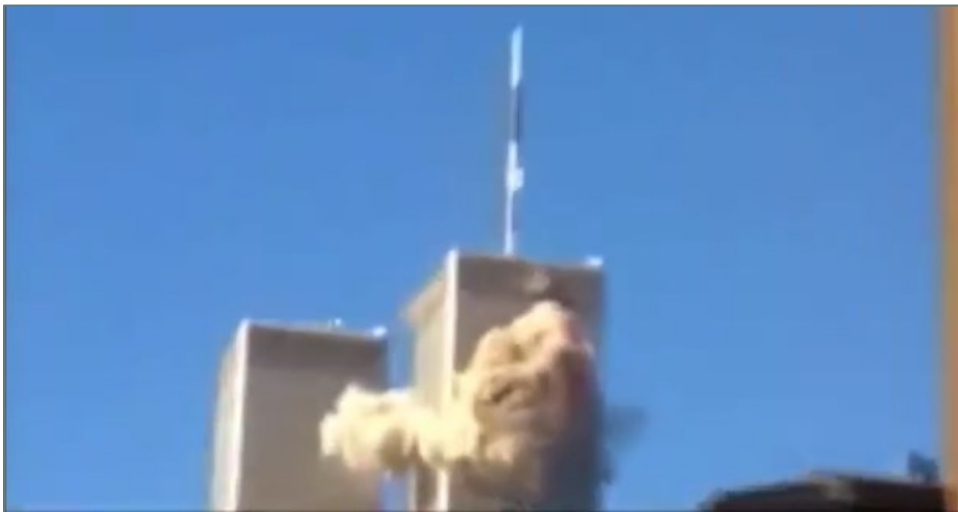
**Figure 55: Ejections from the east face of the North Tower captured by the Naudet Brothers**

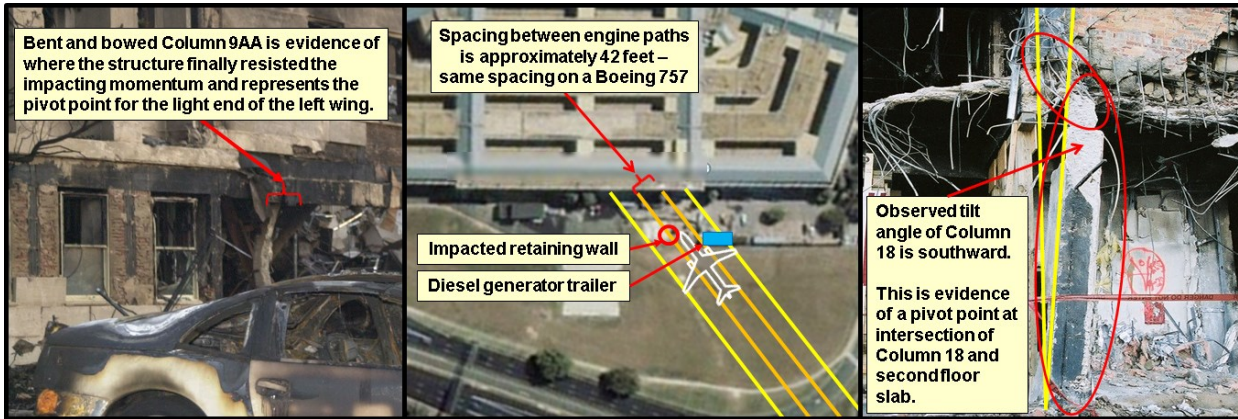
Even the controversy about what impacted the Pentagon has been resolved by a careful analysis of all the observations<sup>45</sup>. Figure 58 describes some of the key observations that define the impacting object at the Pentagon, such as the pivot points for the left and right wing ends, which can only be explained by an object with the dimensions of a Boeing 757<sup>46</sup>. Additionally, because of the timing separation between the two parking gate security cameras, a detailed analysis was able to estimate the impacting plane’s speed across

**Figure 58: Review of the Pentagon damage reveals the pivot points for left (left) and right (right) wings where the building resisted the plane's impacting momentum. The pre-impact damage reveals a 42 foot separation between engines.**
